# Water System Master Plan Update Optimization Study

City of Bend, Oregon, Project No. WA09FA

## **Consequence of Failure Analysis**

FINAL MEMORANDUM

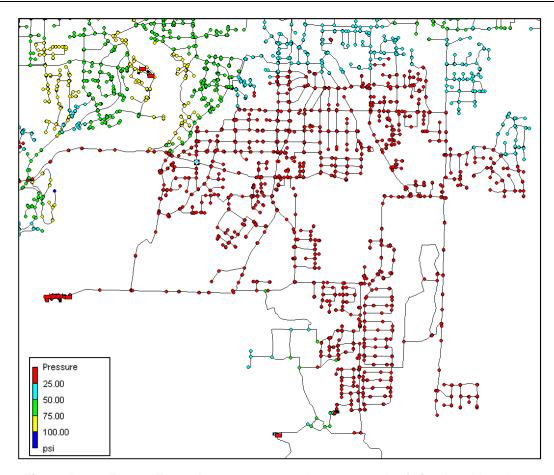
The low pressure constraint used in the analysis was 20 psi. The area that showed the most extreme low pressures under break conditions was a fairly large area of Zone 4 East (4B). Figure 5.14 is a 'snapshot' of the model results from a simulated break on a pipe on Reed Market Road at Brookswood Boulevard under calibration conditions. Pipes on Reed Market Road, SW Bond Street, Brookswood Boulevard, Silver Lake Boulevard, Miller Avenue, Aune Road, 2<sup>nd</sup> Street, 4<sup>th</sup> Street, Wilson Avenue, Chase Road and numerous others caused low pressures at as many as 3,080 customers.

Figure 5.14 – Zone 4 East – low pressure nodes as a result of simulated break on Reed Market Road at Brookswood Boulevard

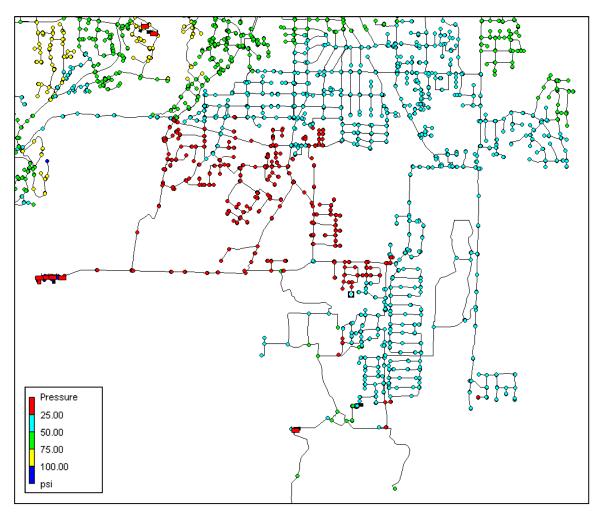
To try and overcome the effects of the break, two pumps in the Scott Street Pump Station and both Bear Creek Well Pumps were turned on in the model and a model simulation was performed. The figure below shows that pressures improved significantly at well over half of the problem nodes. But the figure still shows a pocket of nodes below Reed Market Road and Powers Road that remain below 20 psi even with the additional help from the Scott Street station and the Bear Creek Wells. (Note – the third Scott Street pump was turned on in a subsequent simulation and results showed only a very slight improvement in pressures in this area).

Figure 5.15 – Zone 4 East – some pressure improvement after turning on two Scott Street pumps and the two Bear Creek Well pumps

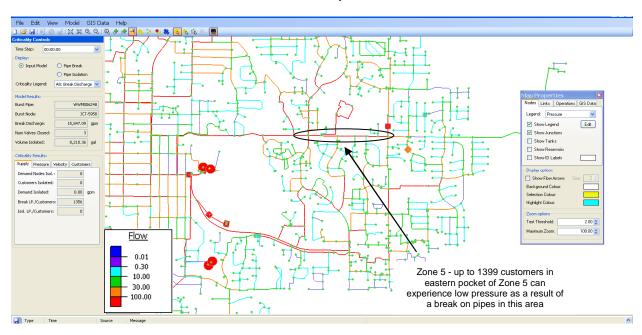
The next most vulnerable area of the system in terms of resulting low pressure in the event of a pipe break is in the eastern pocket of Zone 5. The two figures and Table 5.6 below show that if a pipe were to be broken on NE Neff Road near the St. Charles Medical Center, up to 1,400 customers would suffer a drop in pressure below 20 psi. The table shows the pipes causing the most customers to have low pressure – essentially pipes along NE Neff between Cliff Drive and 27<sup>th</sup> Street as well as on NE Purcell Boulevard and NE Williamson Boulevard. The affected area extends north to the border with Zone 6 and includes the St. Charles Medical Center, and east to the border with Zone 6A.

Figure 5.16 – Zone 5, east end – a pipe break in this area on/near NE Neff Road near St. Charles Medical Center could cause low pressures for up to 1399 customers

This section of Zone 5 is fed by Pilot Butte Reservoirs 1 and 3, which were both supplying a large volume of water under this break scenario. There are no additional supply sources for Zone 5 in this area. This, coupled with the presence of the St. Charles Medical Center – one of the identified critical customers – makes this an area recommended for increased reliability measures in the future.

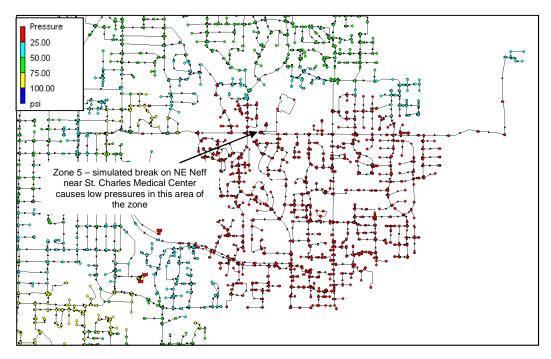
Figure 5.17 – Zone 5, east end – resulting low pressures from simulation of pipe break on NE Neff Road near St. Charles Medical Center

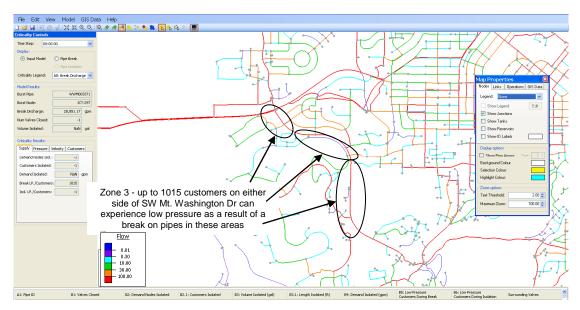
The next most vulnerable area from the standpoint of low pressures from a pipe break is in Zone 3 along Mt. Washington Road from Skyliners Road south down to Chandler Avenue, where Zone 3 feeds Zone 4G, and including Bridge Creek Drive off Mt. Washington. The figures and Table 5.7 below show the approximate locations and the pipes causing vulnerability, as well as the nodes resulting in low pressure. As many as 1,015 customers suffer low pressure depending on the location of the pipe break. The Outback site is the primary supply for this area of the system, pointing to the vulnerability of this part of Zone 3 given a supply interruption along Mt. Washington Drive or on Skyliners Road near Mt. Washington.

Figure 5.18 – Zone 3 – pipe breaks along Mt. Washington Drive south of Skyliners Road cause low pressures to the south and west

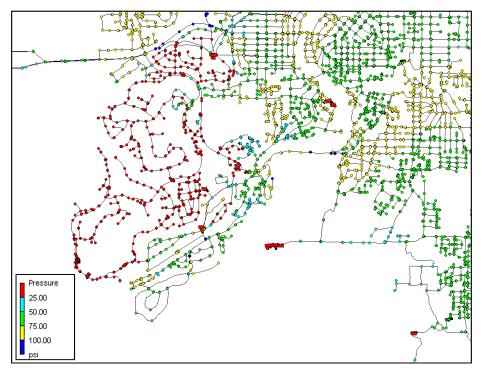
Figure 5.19 – Zone 3 – nodes suffering low pressure based on a pipe break on Mt. Washington Drive just south of Skyliners Road

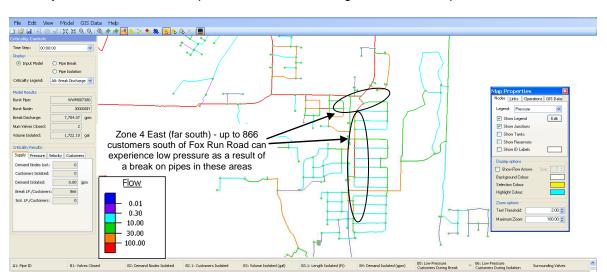
One additional vulnerable location with respect to low pressures from a pipeline break is in the lower part of Zone 4 East (4B), centered on the intersection of Fox Run Road, Brosterhous Road, and American Lane and pipes extending west, northeast, and south of that intersection. The figures below and Table 5.8 show the pipes which, when broken, cause pressures to drop below 20 psi, and the approximate area of nodes and associated customers affected. The worst pipe breaks and number of low pressure customers are listed in the table. Under current operations there are no additional supply sources to turn on in this area of the system, so the area is vulnerable to pipe breaks in these locations. However, planned changes to the Tillicum system will likely modify the way this part of the system operates; additional criticality assessment should be performed after the changes have been implemented.

Figure 5.20 – Zone 4 East (far south) – pipes, when broken, causing potential low pressures south of Fox Run Road

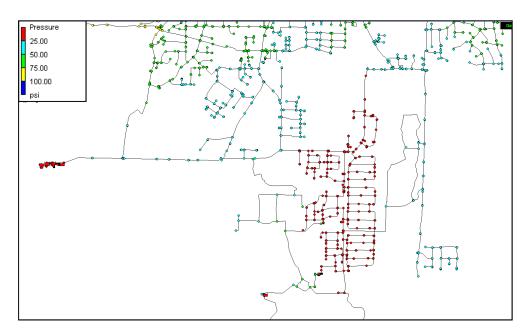
Figure 5.21 – Zone 4 East (far south) – nodes suffering low pressure based on a pipe break along
Fox Run Road or Brosterhous Road

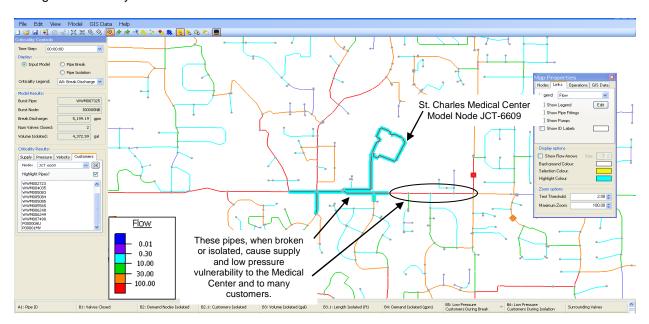
Figure 6.1 – Priority Area 1 – highlighted pipes on NE Neff and NE Purcell, when broken or isolated, cause supply and low pressure vulnerability to the St. Charles Medical Center and to numerous customers to the south and north

Center complex from a different main in the network will reduce the vulnerability of the Medical Center. One or more parallel mains should be considered along NE Neff Road and NE Purcell Boulevard to strengthen reliability in this section of the network.

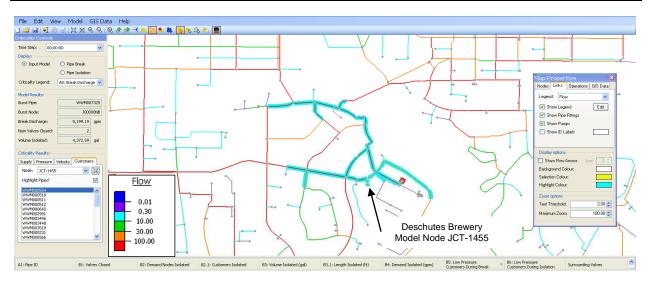
# Priority Area 2 - Zone 5 - Deschutes Brewery area off SW Simpson Ave and SW Colorado Ave

Though the criticality program did not indicate that pipes in this area, should they break or be isolated for repair, would isolate a large number of customers or cause low pressures, this location is considered a high priority area given the presence of critical customer Deschutes Brewery. Figure 6.2 shows the pipes which, if broken or isolated for repair, could have an adverse effect on supply and service pressure to the Brewery. Fortunately there are several pipe routes to the area should a break or isolation take place on a nearby main, and many of these pipes - on SW Colorado, SW Simpson, and SW Shevlin Hixon – are 16-inch diameter and able to carry significant flow. The figure and model do, however, show that there is only one 10-inch diameter feed to this customer from an 8-inch diameter pipe on SW Simpson Avenue. At least one additional feed into the Brewery from a different main will help to improve reliability in the event of a supply interruption.

Figure 6.2 – Priority Area 2 – highlighted pipes on SW Simpson, SW Colorado, and SW Shevlin Hixon, when broken or isolated, cause supply and low pressure vulnerability to the Deschutes Brewery location

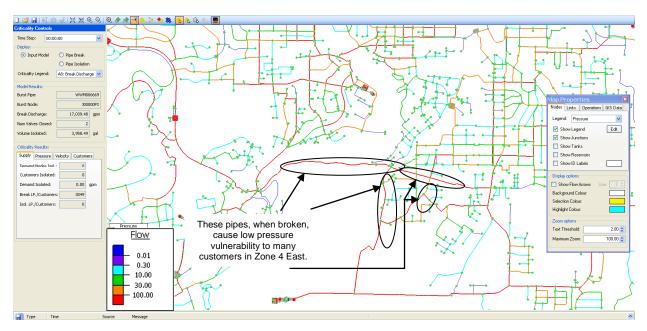
### Priority Area 3 - Zone 4 East (4B) - pipes on Reed Market Road and other streets

Figure 6.3 – Priority Area 3 – Zone 4 East – area served by Reed Market Road main and additional mains on nearby streets, when broken or isolated, cause supply and low pressure vulnerability

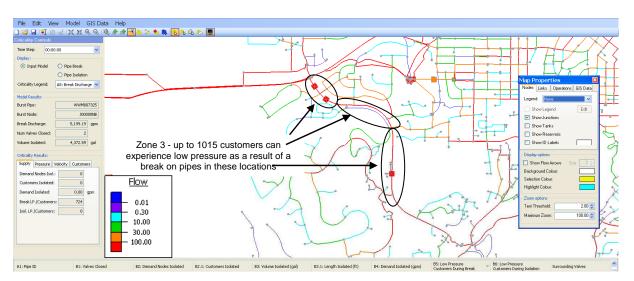
The criticality results indicated that anywhere from 690 to 1,015 customers could suffer low pressure in the event of a pipe break on Mt. Washington Drive south of Skyliners Road down to Mountaineer Way. Figure 6.4 shows the critical pipe locations. The affected customers are primarily in that section of Zone 3 which is just west of Mt. Washington Drive and south of Zone 4K. The system maps and model show that there is only one feed into this area of the network – the 12-inch diameter Bridge Creek Drive take-off from Mt. Washington Drive – which explains the isolation vulnerability. At least one additional feed into this part of Zone 3 should be implemented to provide redundant supply and reduce the vulnerability.

Figure 6.4 – Priority Area 4 – Zone 3 – pipe breaks along Mt. Washington Drive south of Skyliners Road, when broken or isolated, cause low pressures and/or isolation of just over 1,000 customers

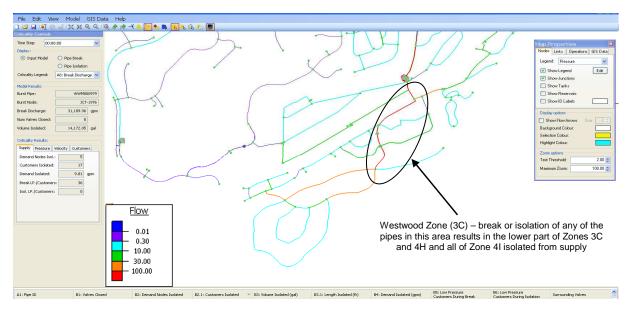
The pipe criticality simulations showed that a pipe break or isolation on any of 8-10 pipes south of the Westwood Pump Station – essentially pipes on Mt. Bachelor Drive or Mammoth Drive (see Figure 6.5 below) – isolates the whole lower end of the Westwood Zone as well as Zone 4l. Based on the customer count this could mean up to nearly 550 customers isolated.

Figure 6.5 – Priority Area 5 – Westwood Zone (3C) – pipes south of Westwood Pump Station on Mt. Bachelor Drive or Mammoth Drive, when broken or isolated, cause isolation of more than 500 customers

One or more additional feeds into the lower part of the Westwood Zone from the north are recommended for implementation. This would provide backup supply in the event of a break or isolation on the Mt. Bachelor Drive and Mammoth Drive mains.

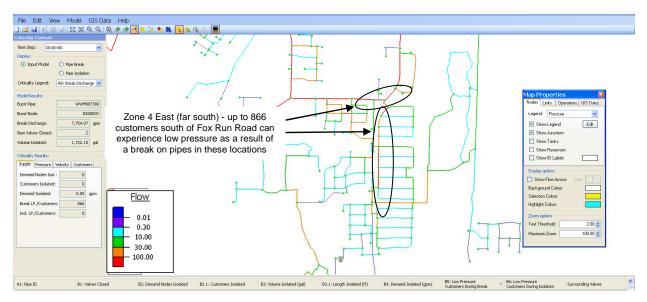
#### Priority Area 6 - Zone 4 East (4B) - Brosterhous Road / American Lane / Fox Run Road

Figure 6.6 – Priority Area 6 – Zone 4 East (4B - south) – pipe breaks along Brosterhous Road, American Lane, Fox Run Road, and Fairfield Drive cause low pressures and/or isolation of up to 875 customers

Figure 6.6 shows the area of concern. Strengthening redundancy in this section of Zone 4 East is recommended. The planned modifications to the Tillicum area may provide the necessary strength; further review is warranted during design of the new improvements and operating measures.

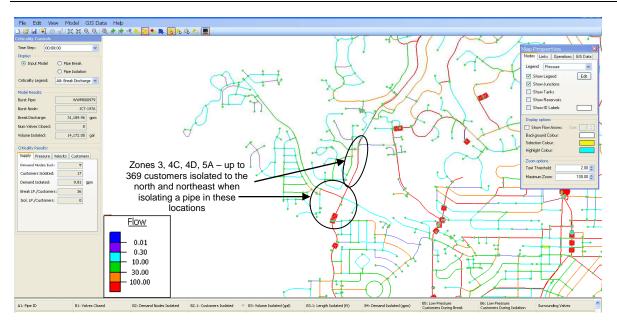
### Priority Area 7 - Zone 3 - Intersection of Mt. Washington Drive and Shevlin Park Road

Figure 6.7 – Priority Area 7 – Zone 3, 4C, 4D, 5A – pipe breaks along Mt. Washington Drive, Shevlin Park Road, and NW Nordic Avenue cause isolation of up to 369 customers

It is recommended that the City consider the strategic addition of new mains in this location to add redundancy and reduce reliance on one supply point into the zone and subzone areas noted above.
