# City of Bend Bridge Creek Water System 2017 Tumalo Creek Fish Monitoring Report

Tom Walker, Bend/Ft. Ranger District Fisheries Biologist 11/21/2017

In accordance with the monitoring requirements for the Operation of the City of Bend Bridge Creek Water System (start-up 4/2016), under Special Use Permit with the Deschutes National Forest, fish populations in Tumalo Creek are to be monitored to assess effects from operation of the new system. Monitoring is to occur annually during 2016-2018, then every other year through 2024.

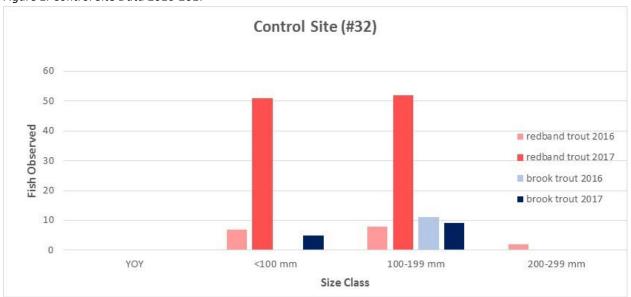
Figure 1. Control Site Data 2016-2017

The Control Site was established in 2016 and repeated in 2017. The numbers of redband trout were significantly larger in 2017 compared to 2016, increasing from a total of 17 to 103. Similar increases were seen in both the <100 mm and 100-199 mm size classes. No large redband trout (>200 mm) were observed in 2017. Brook trout numbers had little change between 2016 and 2017, increasing slightly from 11 to 14 total fish.

The establishment of the Control site in 2016 gives insight to how environmental variables might influence the fish population. Redband trout numbers were significantly higher in 2017 compared to 2016, an increase of a multiple of 6 (Figure 1). Likely the largest factor was the considerable water temperature differences between the two years, just 3.1°C in 2016 but 9.0°C during the 2017 survey (Table 2). With the onset of winter, fish may move into different habitats or become concealed in the substrate, making observation during surveys difficult, and biasing the data. Other potential contributing factors include: (1) the winter of 2016-2017 experienced a good snowpack and resultant run-off, a "good" water year, which may have increased available habitat and food supply (Figures 9 and 10); (2) the Bridge Creek diversion at the headwaters was closed during the winter months of 2016-2017 (unplanned anomaly), resulting in additional discharge through the Control site, potentially benefiting wintering habitat; and (3) an increased population of redband within the project area resulting in individuals moving upstream into the Control site. Interestingly, the brook trout numbers only slightly increased (Figure 1) within the Control site.

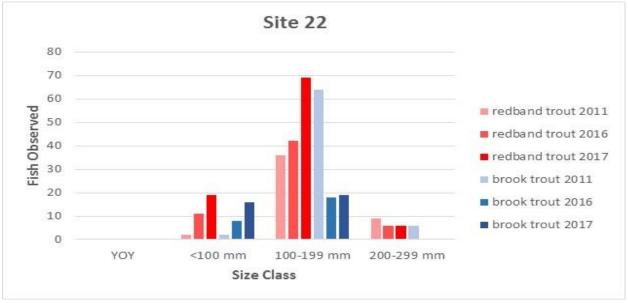
Figure 2. Site 22 Data 2011, 2016, 2017

Site 22 experienced an increase in redband trout between 2016 and 2017 in both the <100 mm and 100-199 mm size categories, while the large trout remained similar. Overall, the redband trout numbers increased from 59 to 94. Brook trout numbers were similar between 2016 and 2017, but slightly increased from 26 to 35. For trend analysis, 2011 data is also presented, although this was before the establishment of the Control site. The trend

since 2011 has been an overall increase in redband trout and an overall decrease in brook trout numbers. Within the side channel, no redband trout were observed in 2017, but just one was observed in 2016. Brook trout numbers decreased from 87 to 72. The side channel is filling in with silt and is difficult to snorkel because of significant shallow depths and heavy brush. Starting in 2018, the side channel may be electrofished rather than snorkeled.

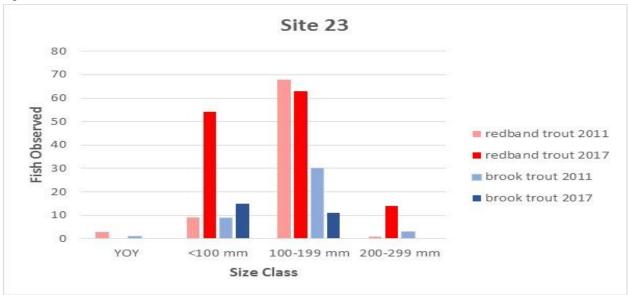
Figure 3. Site 23 Data 2011, 2017

Site 23 was not monitored in 2016. A comparison between the 2011 and 2017 data is displayed above. The trend in fish populations is an overall increase in redband trout, from 81 to 131 total. Significant increases in the <100 mm and 200-299 mm sizes were responsible for the increase. Overall, a decrease in brook trout was observed, dropping from 43 to 26 fish observed.

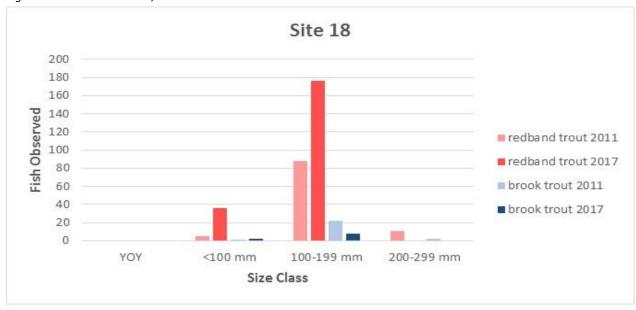
Figure 4. Site 18 Data 2011, 2017

Site 18 was not monitored in 2016. A comparison between the 2011 and 2017 data is displayed above. The trend in fish populations was a very large increase in redband trout numbers, rising to a total of 212 from 104, due to increases in the small and medium sizes. Brook trout numbers dropped from 25 total to 10. No large redband trout were observed in 2017.

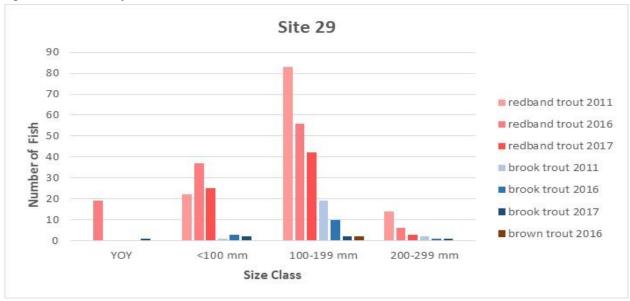
Figure 5. Site 29 Data from 2011, 2016, 2017

Site 29 was monitored in 2016 and 2017. Data from 2011 is also presented. Fish observed in 2011 were very similar to what was observed in 2016, other than redband trout observed were smaller overall. Between 2016 and 2017, redband trout numbers decreased across all age classes, with total numbers dropping to 70 from 118. Brook trout numbers also decreased, from a total of 14 to 6. While two brown trout were observed in 2016, none were observed in 2017.

Assessing project operation effects since operations began in April 2016 is not possible at this time due to two sites (18 &23) not being surveyed in 2016. Personnel shortages and numerous high precipitation events during the fall precluded finishing the surveys. Therefore, the only sites comparable between 2016 and 2017 are the Control (Site 32) and Sites 22 (including the side channel – Site 22SC) and 29. An increase in redband trout and brook trout was observed in Site 22 while a decrease in both species was observed in Site 29 (Figures 2 and 5). Similar numbers of fish were observed comparing 2011 with 2016 within Site 29, despite a considerable
