# US 97 Parkway Plan TECH MEMO #2: EXISTING CONDITIONS

DATE: December 13, 2017

TO: US 97 Parkway Plan Project Team

The purpose of this memorandum is to describe existing transportation conditions for US 97 and the US 97 Bend Parkway through the city of Bend. This includes a description of the geometric characteristics, frequencies and types of access provided, traffic controls, modes of travel served, traffic volume characteristics, conditions for walking and biking, safety conditions, levels of congestion, and the reliability of travel times through the corridor. A summary of the key findings from this memorandum is provided below, with further information included in the subsequent sections.

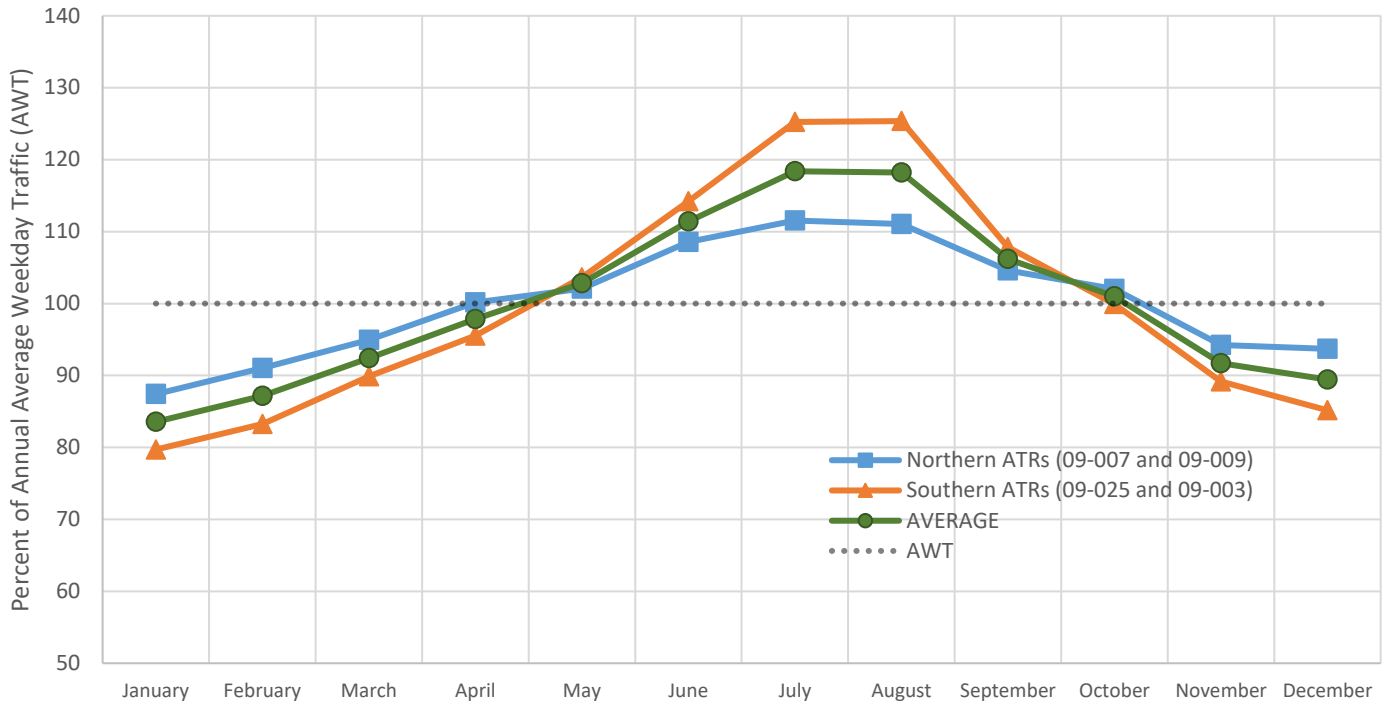
**Figure 15: US 97 ATR Average Weekday Traffic Seasonal Trends through Bend**

The steeper increase in summer traffic volumes compared to winter at the southern ATRs likely indicates a higher recreational proportion of traffic compared to the more commuter-oriented traffic profile of the northern ATRs. All four ATR counts indicated that July conditions best represent the 30 HV. However, the traffic counts for the study area were collected the week of April 10. To adjust these counts to represent July conditions, two different seasonal factors were applied to the north and south ends of the corridor. As a result, all counts collected from Truman Road to the north were increased by 11 percent. All counts collected south of Pinebrook Boulevard were increased by 31 percent. Counts between Truman Road and Pinebrook Boulevard were gradually increased by 11 to 31 percent, maintaining balanced volumes along the corridor.

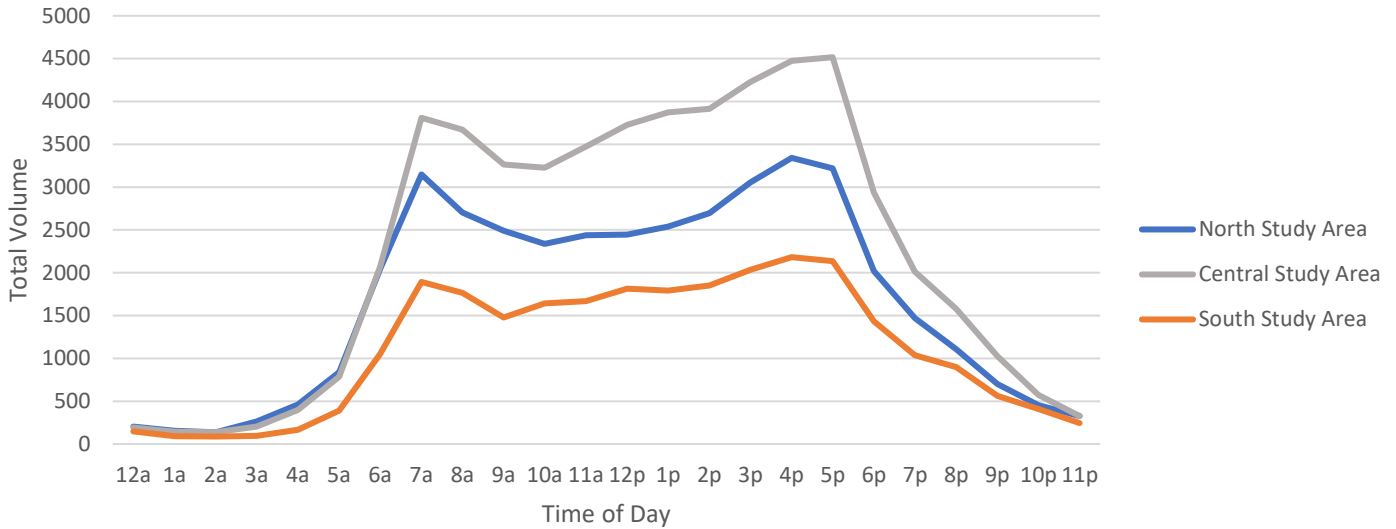
**Figure 16: Average Weekday Traffic Volume Profile by Study Area**

As shown in, Figure 16 traffic peaks sharply in the morning around 7:00 AM, decreases until about 10:00 AM, then gradually increases and peaks again around 5:00 PM. PM peak traffic volumes are significantly higher than those in the AM peak. The Central Study Area experiences the greatest traffic volumes, while the South Study Area experiences the lowest. Though the magnitude varies along the corridor, the pattern over the day is similar for each study area. These trends informed the selection of a single system peak hour for use in the analysis.

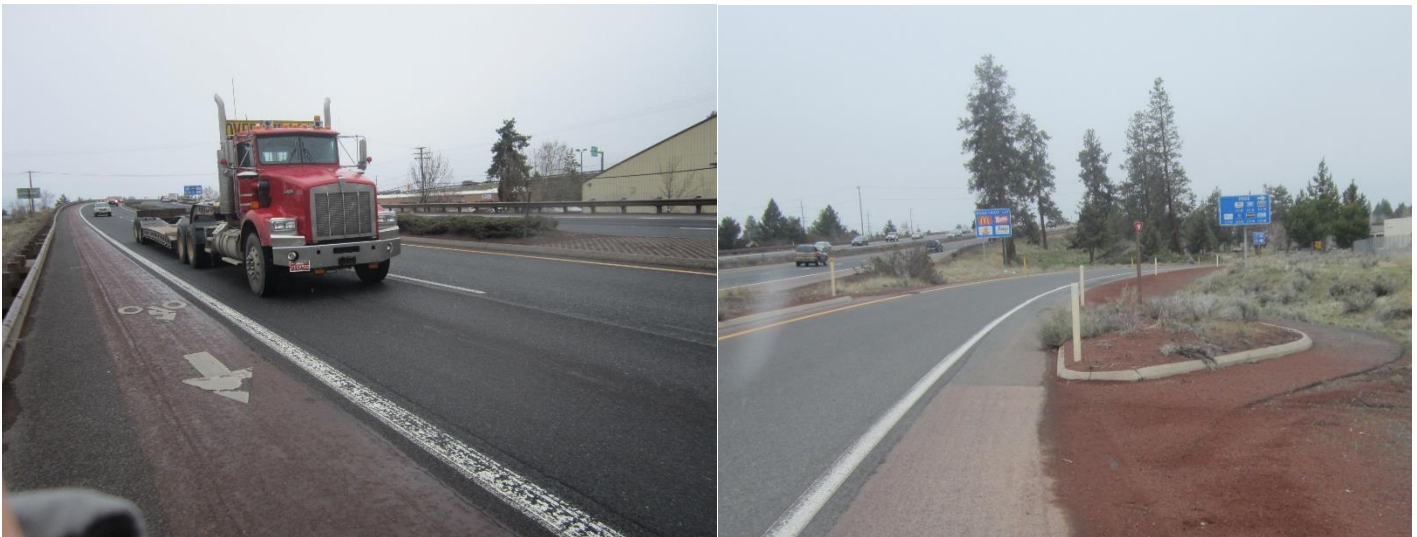
**Figure 23: Bike Facility Examples**

Based on the field observation, the cycling conditions along the US 97 study corridor could be perceived as very stressful due to the multiple ramp crossings and proximity to higher speed vehicles.

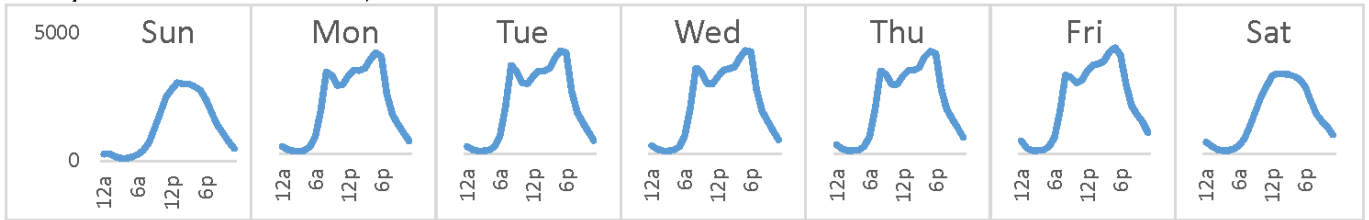
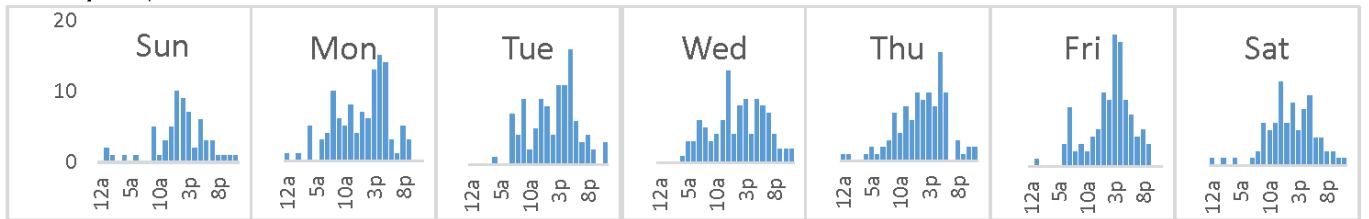
**Figure 24: Crash Calendar – Total Crashes<sup>11</sup>**

Crash calendars were developed to illustrate the pattern of crashes over the five-year period, 2011-2015, by month, day, and periods within each day. The calendars display these trends for total crashes (Figure 24), for severity of crashes (Figure 25), and for road condition and selected causes (Figure 26).

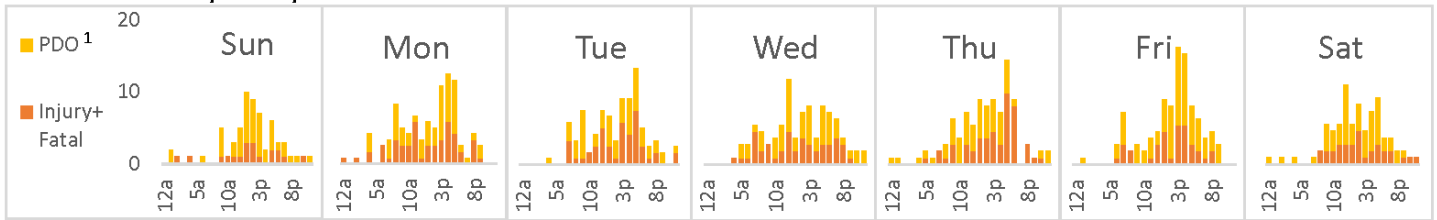
### Figure 25: Crash Calendar – Severity

Overall, approximately 58 percent of all crashes resulted in only property damage. Fridays have the greatest number of property damage crashes, while midweek days like Monday, Tuesday, and Thursday tend to have higher numbers of crashes that result in injuries.

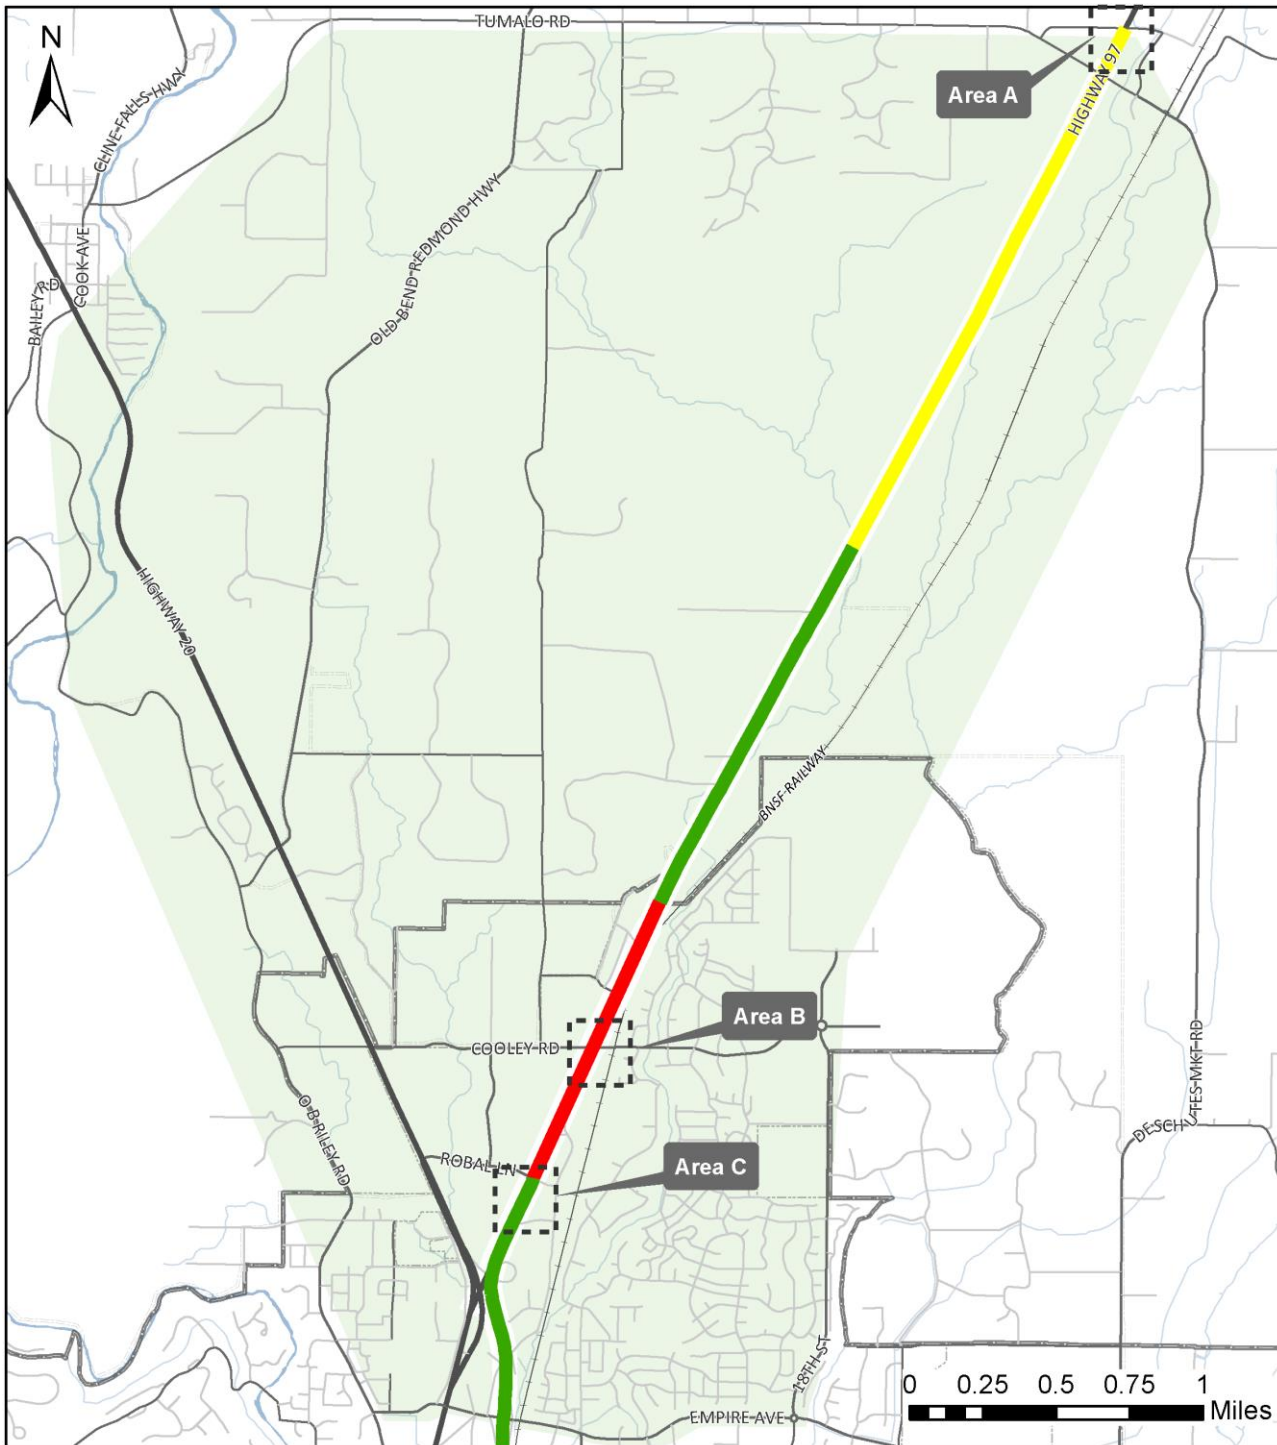
Figure 27

Figures 27-29 illustrate the findings from Table 6, showing observed segment crash rates compared to statewide average crash rates. They also identify clusters of study intersections (shown as “Areas”), for which more detailed crash maps are provided in Figures 30-32. These maps show the number of crashes by severity and crash type trends for each intersection, and whether the intersection is flagged as a safety focus area.

**2010-2014 Parkway Segment Crash Rates - North Study Area**

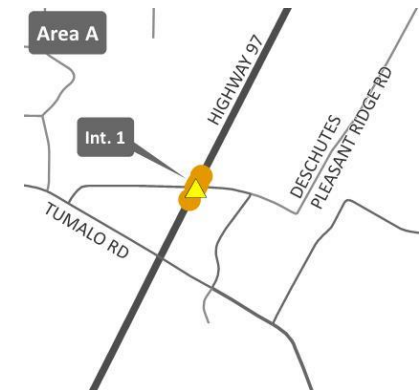
**Figure 30: Intersection Crashes – North Study Area**

**Int. 1: US 97 & Tumalo PI**

Crash Severity  
 1 Serious Injury Crash (Injury A)  
 4 Property Damage Only Crashes

Five intersections were flagged as safety focus areas. The intersections at US 20/Butler Market Road and Bend Parkway Northbound Ramps/Revere Avenue had crash rates only slightly greater than the critical crash rate, but still lower than the 90<sup>th</sup> percentile crash rate. In contrast, the intersections at Bend Parkway Northbound Ramps/Reed Market Road, Bend Parkway/Pinebrook Boulevard, and US 97 Southbound Ramps/Baker Road had crash rates much greater than the critical and 90<sup>th</sup> percentile crash rates. It should be noted that in 2015, the intersection of Bend Parkway/Pinebrook Boulevard was reconstructed from a full-movement signalized intersection to an unsignalized intersection allowing only right-in/right-out turning movements, which may have mitigated the high crash rate. Although it was not flagged as a safety focus area the intersection of US 97 Northbound Ramps and Knott Road has a guardrail that gets hit frequently by drivers making a left turn onto the northbound ramp, possibly due to a tight turning radius.

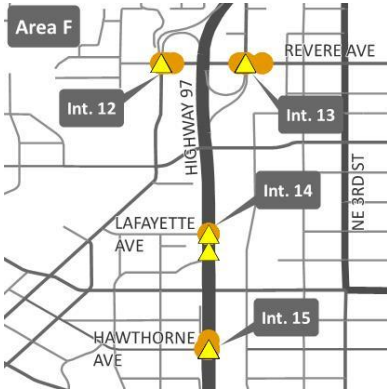
Figure 31: Intersection Crashes – Central Study Area

**Int. 12: Bend Pkwy SB Ramps & Revere Ave**  
**Flagged as Safety Focus Area**

Crash Severity  
 1 Serious Injury Crash (Injury A)  
 5 Non-serious Injury Crashes (Injury B & C)  
 8 Property Damage Only Crashes

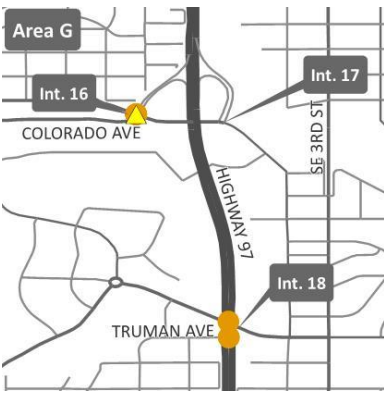
**Int. 16: Bend Pkwy SB Ramps & Colorado Ave**  
**Flagged as Safety Focus Area**

Crash Severity  
 1 Non-serious Injury Crashes (Injury B & C)  
 5 Property Damage Only Crashes

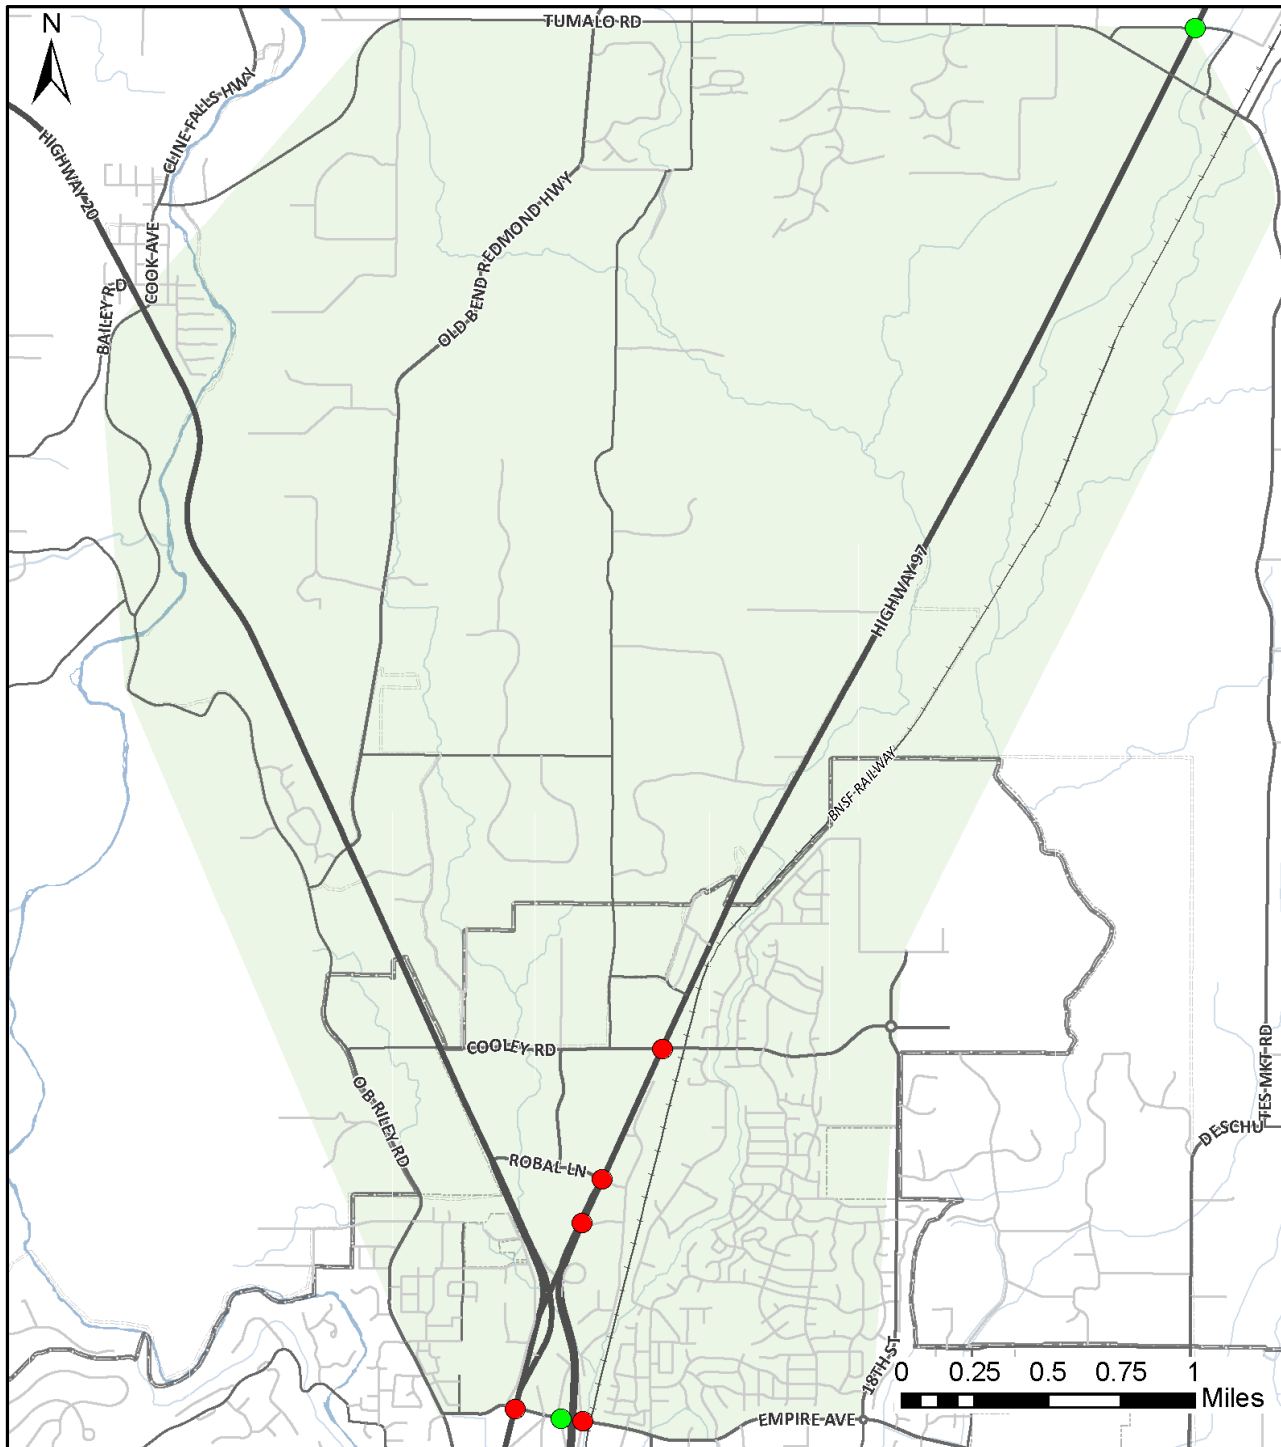
Figure 36

Eight of the 17 unsignalized intersections and eight of the 11 signalized intersections fail to meet adopted mobility targets. This indicates that there is a significant amount of congestion at study intersections throughout the corridor during the peak hour. Figures 36-38 summarize intersection performance for the North, Central, and South study areas.

**Intersection Operations Analysis - North Study Area**

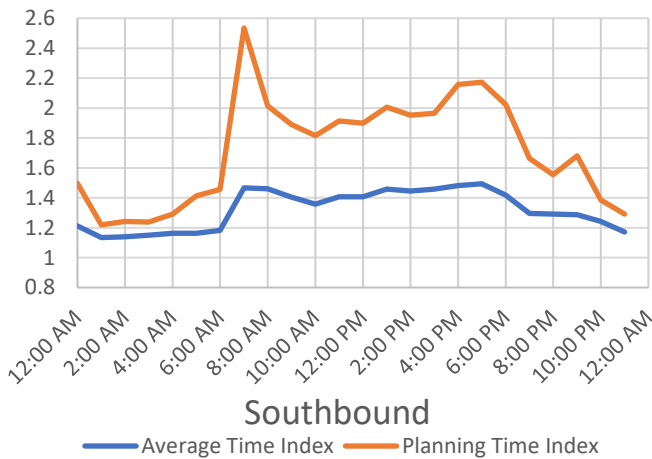
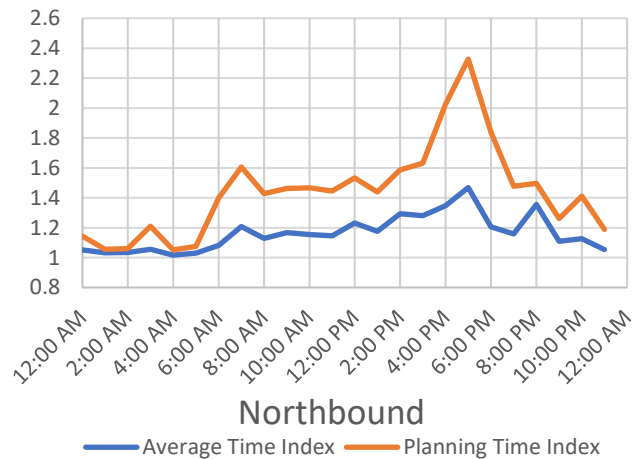
**Figure 42: Travel Time Reliability - North Study Area**

Figures 42-44 show 24-hour travel time reliability measures for southbound and northbound directions. The AM and PM peak hours tend to have less reliable travel times. Due to the congestion and crashes associated with the peak hours, travel time is more variable, especially at the at-grade intersections. This effect is more pronounced in the North Study Area. However, even during the peak hours, travel time reliability remains relatively good in the Central Study Area.
