## DRAFT TECHNICAL MEMORANDUM

### Baseline Data Collection Memo

Bend Safety Implementation Plan

Date: August 25, 2014 Project #: 17437.0  
To: Robin Wilcox, ASLA, PLA  
From: Casey Bergh, PE and Ashleigh Griffin  
cc: Scott Beaird, PE

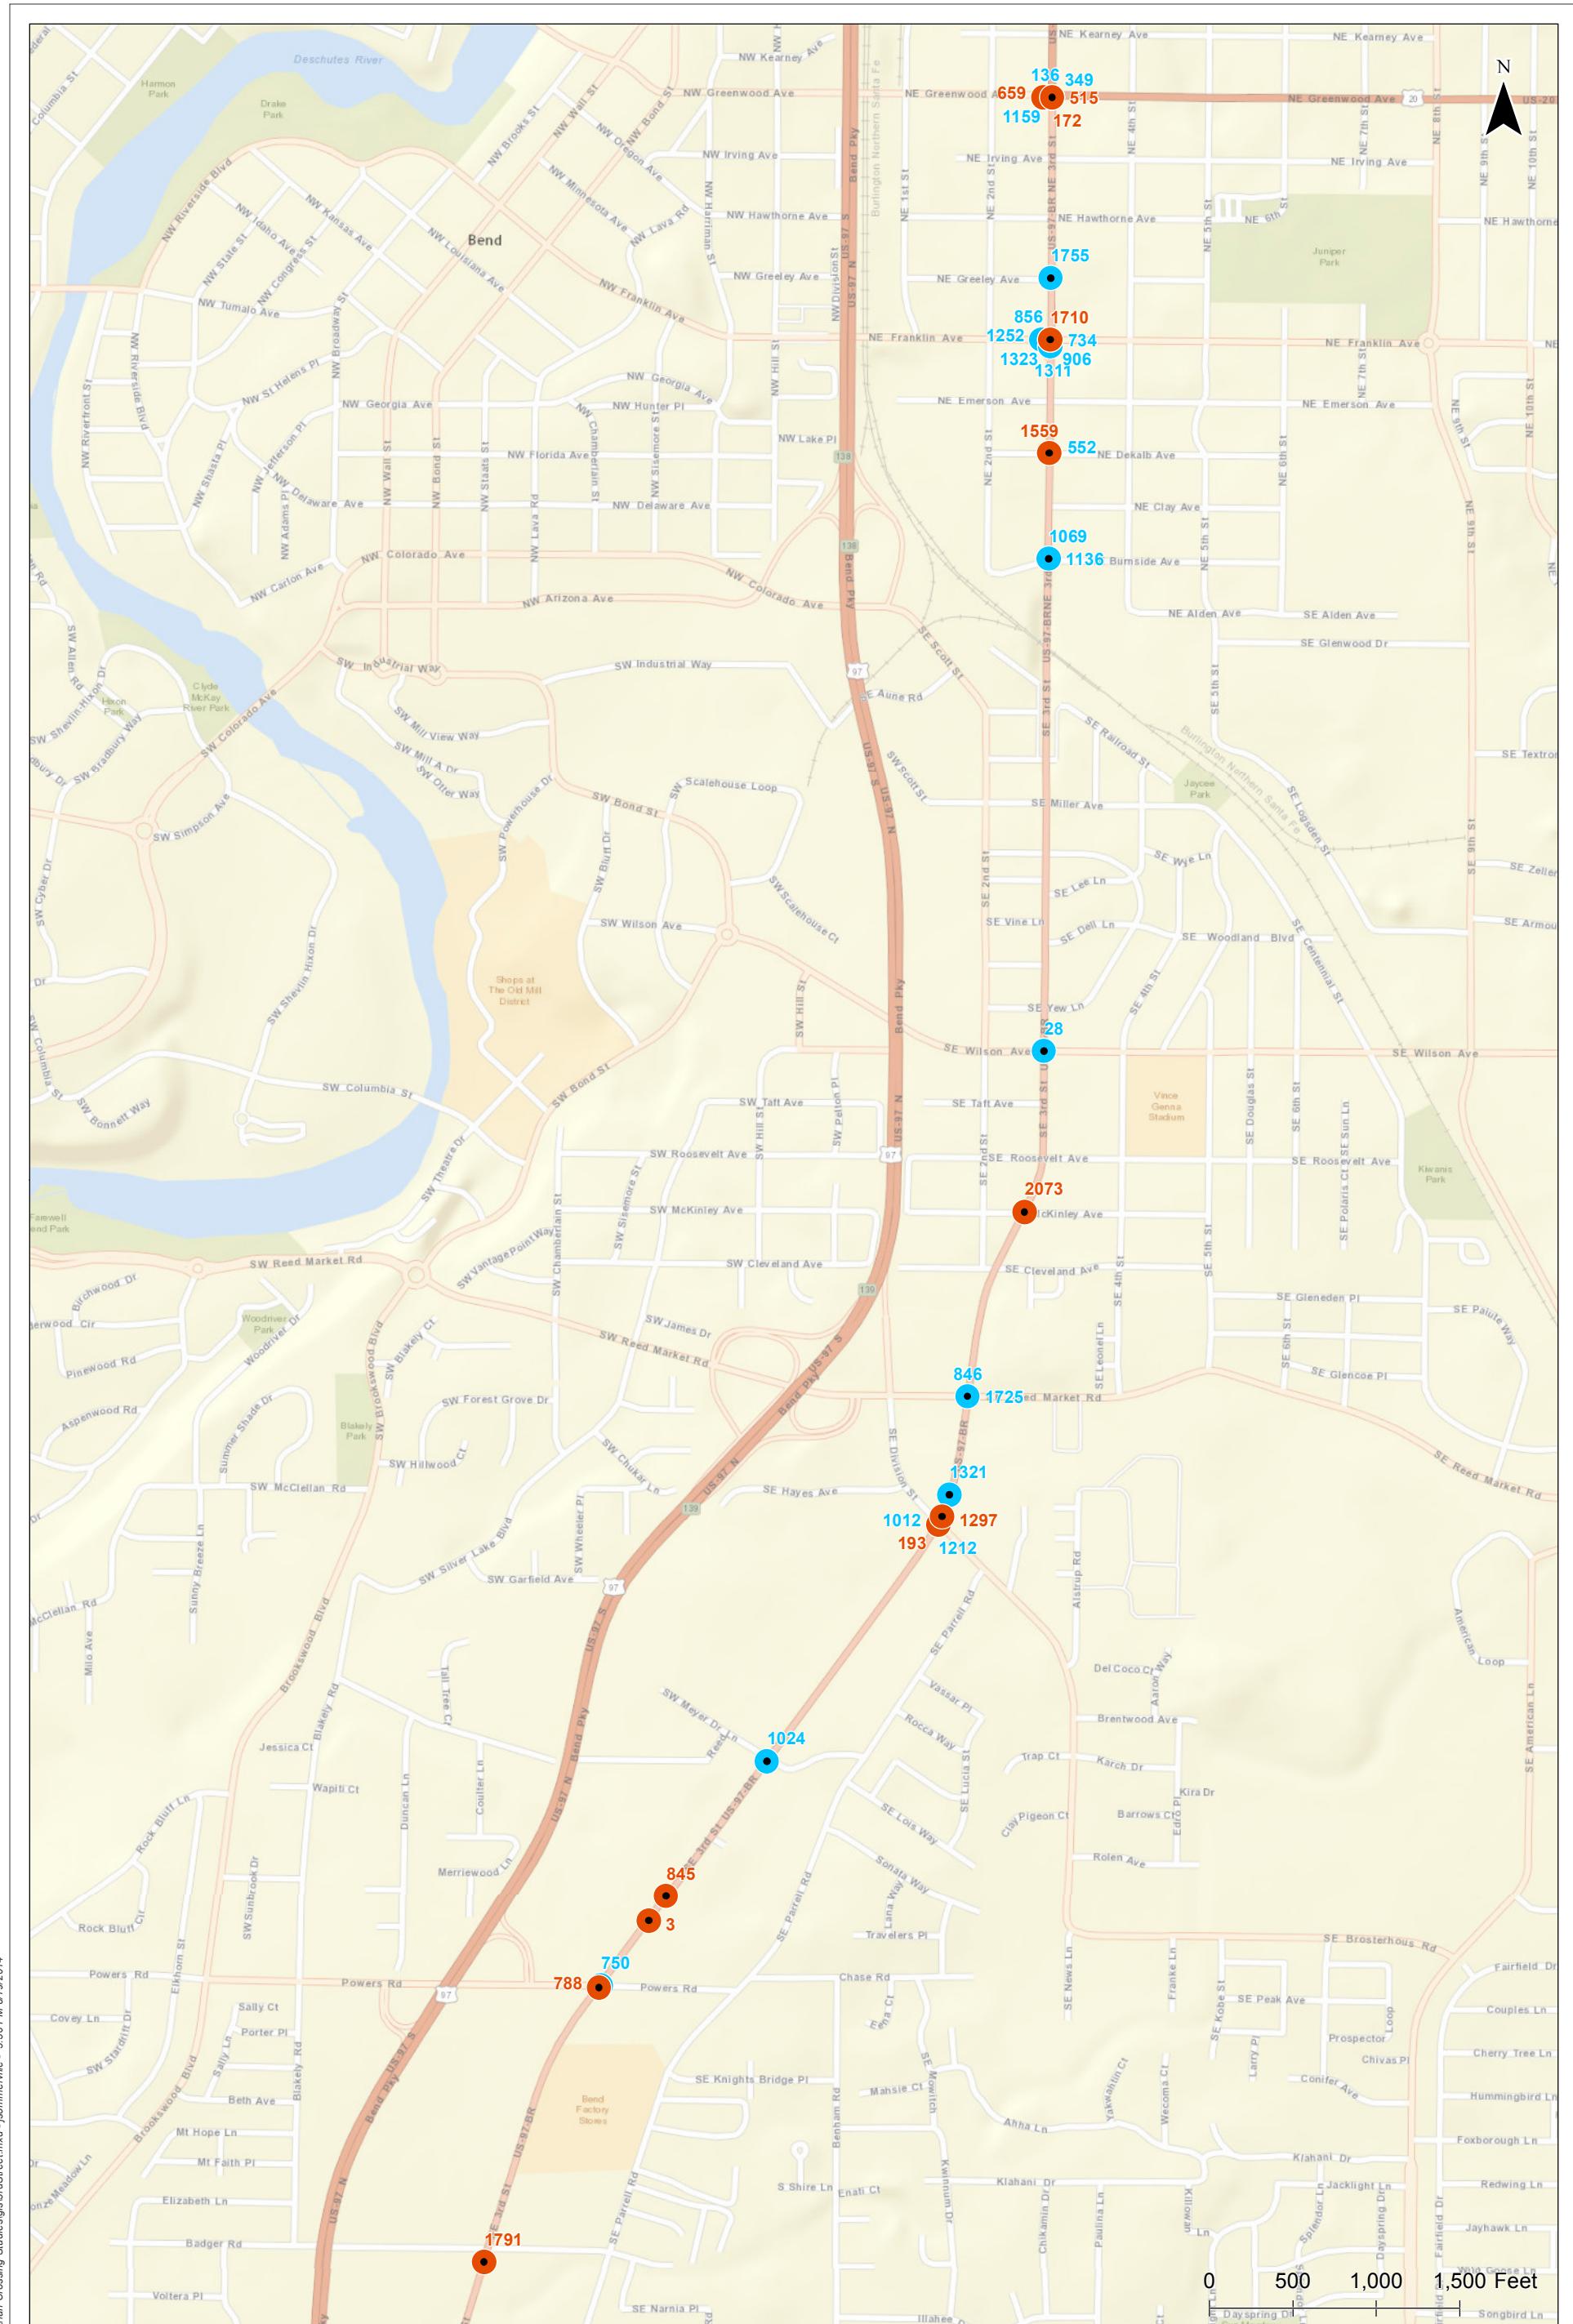
Figure

**Reported Pedestrian and Bicycle Crashes (2007-2013)**  
**NE 3rd St: Greenwood Ave to Murphy Rd**  
**Bend, Oregon**

No crashes reported between Badger and Murphy Road

The locations of pedestrian and bicycle crashes are illustrated, by crossing corridor, in Figures 1 through 3. Tables A-1 through A-3 in Appendix A provide additional information about each crash shown in the figures.

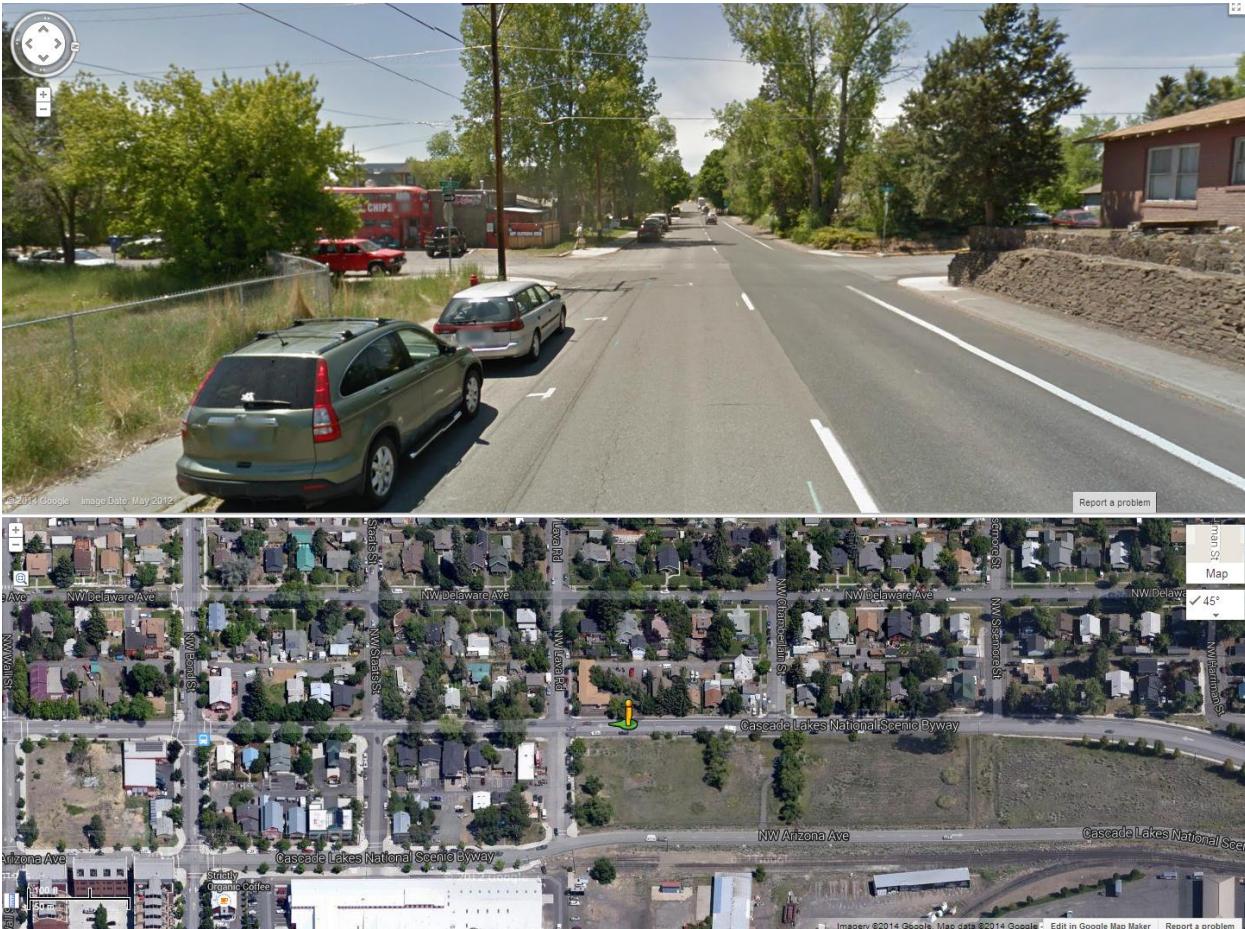
## COLORADO AVENUE/LAVA ROAD

Corridor Crossing Plan: Colorado Avenue

Intersection Name: Lava Road

Date/Time: July 16, 2014 from 4 p.m. to 5 p.m.

Staged crossings were conducted on Colorado Avenue at NW Lava Road and NW Staats Street on Wednesday, July 16, 2014 from 4 to 5 p.m. These locations were selected because they provide north-south unsignalized crossing connections between the residential area north of Colorado Avenue and the Old Mill commercial area to the south.

- On-street parking on the south side of Colorado Avenue influenced yielding rates for northbound staged crossings from the SE corner to the NE corner of the intersection.
- Curb bulb outs on the south side of Colorado Avenue at Staats Street increase pedestrian visibility and influenced yield rates.
- When the downstream signal at Bond Street displayed a red indication for Colorado Avenue traffic, drivers were more likely to yield to the staged pedestrian crossing between the NW and SW corners of the Staats Street intersection.

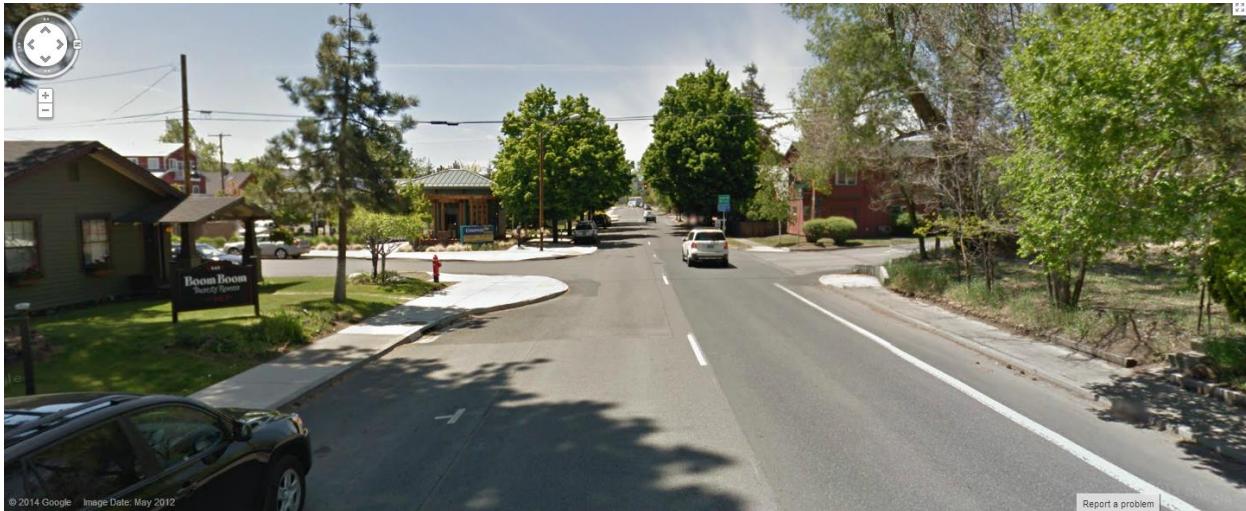
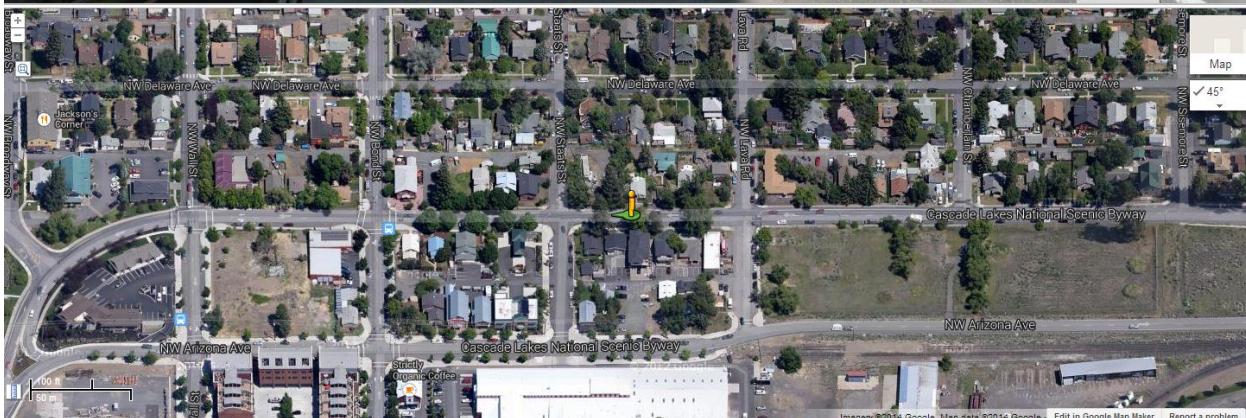
## COLORADO AVENUE/STAATS STREET

Corridor Crossing Plan: Colorado Avenue

Intersection Name: Staats Street

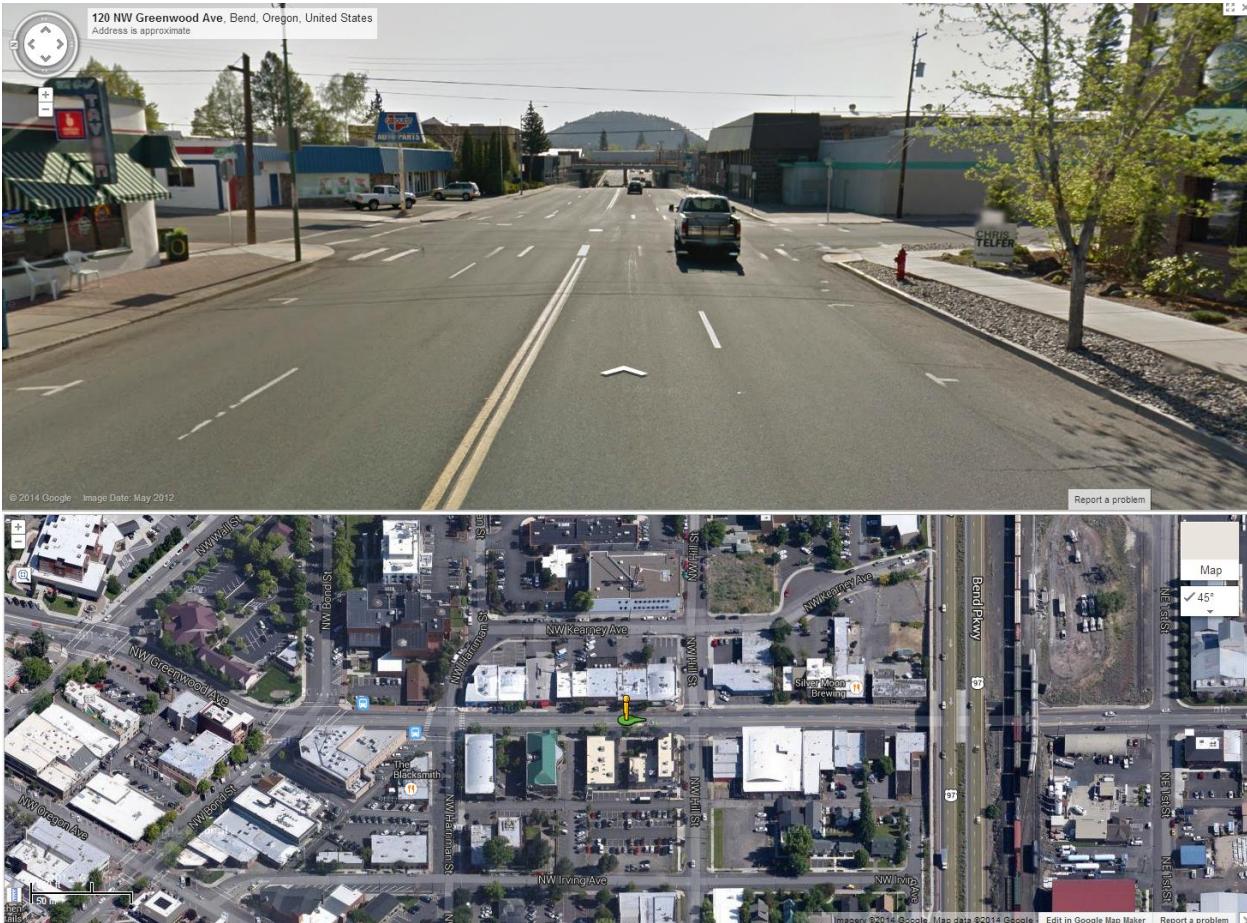
## GREENWOOD AVENUE/HILL STREET

Corridor Crossing Plan: Greenwood Avenue (West)

Intersection Name: Hill Street

The crossing of Greenwood Avenue at Hill Street was observed on Friday, July 18, 2014 from 4 to 5 p.m. This crossing location was identified as a priority during the development of the City of Bend Safety Management Plan due to vehicular crashes. At Hill Street, Greenwood Avenue has a four-lane cross-section with on-street parking that limits pedestrian sight distance.

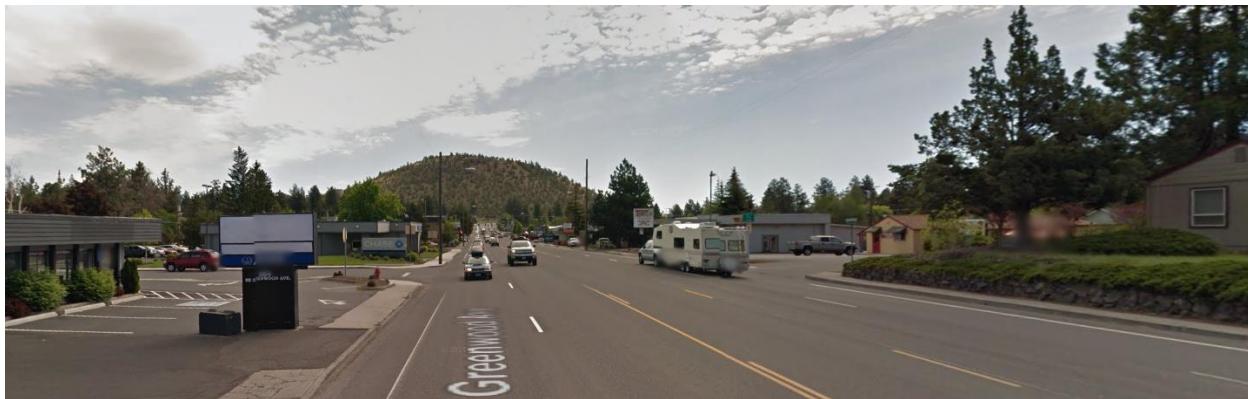
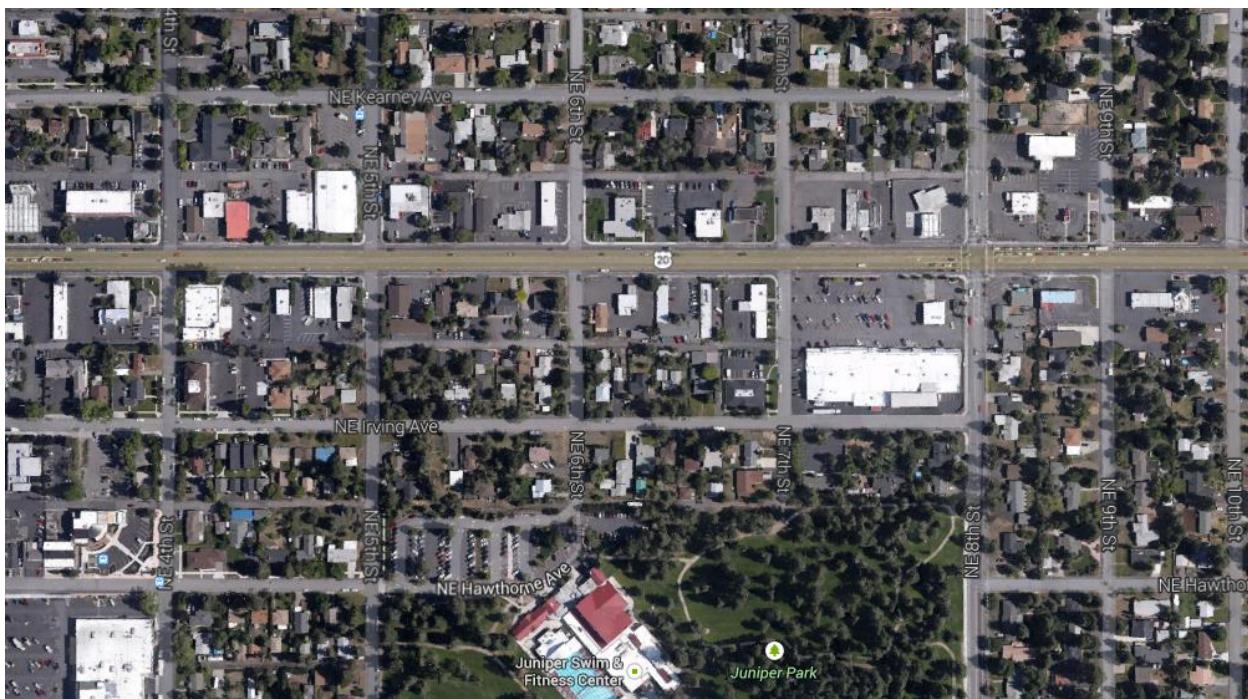
## GREENWOOD AVENUE/6<sup>TH</sup> STREET

## Corridor Crossing Plan: Greenwood East

Intersection Name: Greenwood at 6th

Crossings were staged and observed between the SW and NW corners of Greenwood Avenue at NE 6<sup>th</sup> Street on Friday, August 15<sup>th</sup>, 2014 from 4 to 5 p.m. This crossing location was selected to accommodate crossings between the Juniper Swim and Fitness Center and local residential areas and schools north of Greenwood Avenue. At NE 6<sup>th</sup> Street, Greenwood Avenue has a five-lane cross-section, including four travel lanes and a center turn lane.

Crossing gaps reflect vehicle platooning resulting from upstream and downstream signals. Statistics in **Table 2** reflect the number of vehicles in the two lanes closest to the pedestrian. Drivers were approximately 2.5 times more likely to yield to a pedestrian waiting in the median than a pedestrian on the sidewalk.

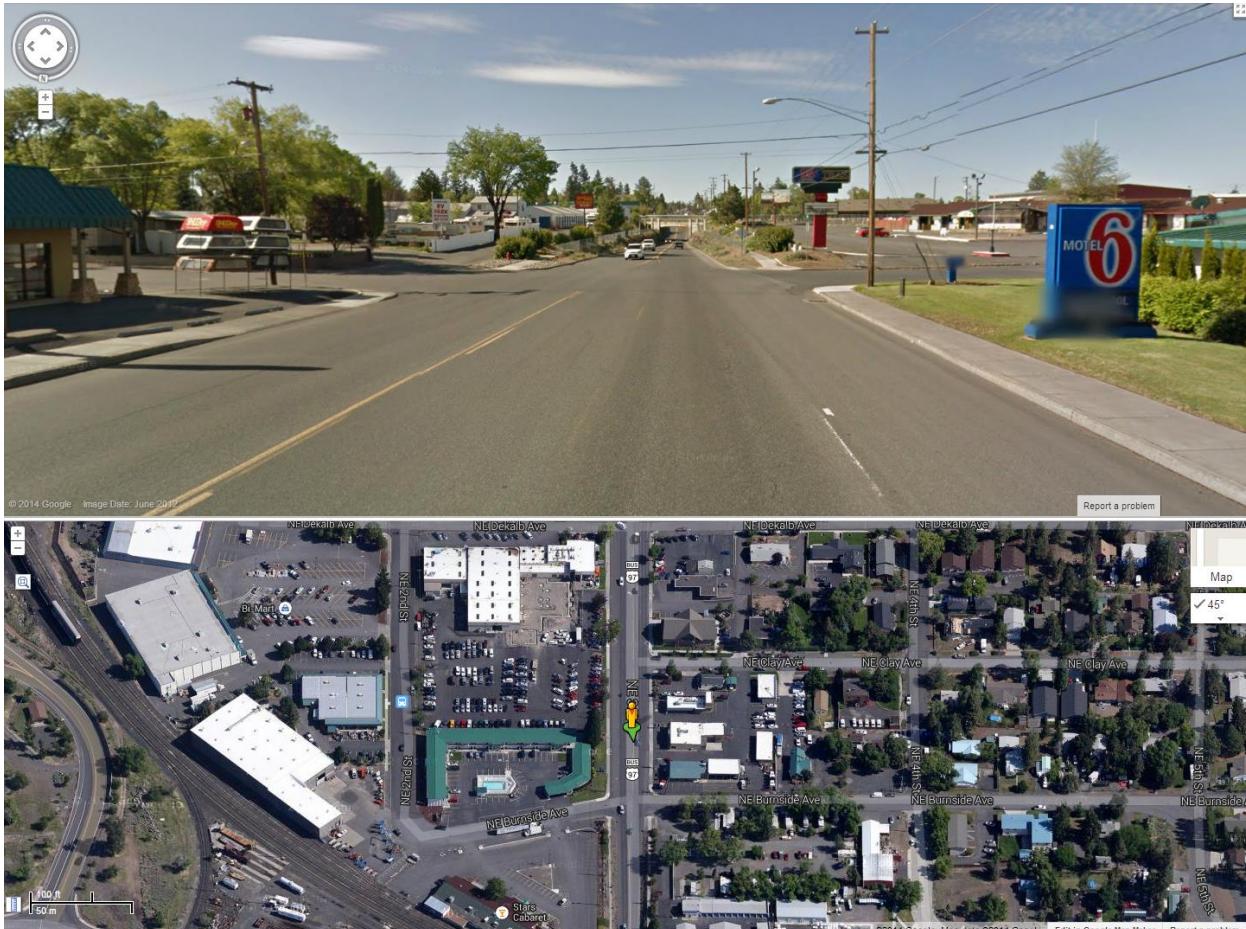
## 3<sup>RD</sup> STREET/BURNSIDE AVENUE

## Corridor Crossing Plan: 3rd Street

Intersection Name: Burnside Avenue

Five-lane crossings were staged and observed between the NW and NE corners of the NE 3<sup>rd</sup> Street/Burnside Avenue intersection on Friday, July 18, 2014 from 4 to 5 p.m. This crossing location was selected to accommodate crossings from east of NE 3<sup>rd</sup> Street (residential land use and Bend High School) to/from the commercial attractors to the west of NE 3<sup>rd</sup> Street. Immediately south of the intersection NE 3<sup>rd</sup> Street is reduced to a two-lane cross-section through the railroad undercrossing.

- Due to heavy traffic volumes and travel speeds, nine crossing attempts were aborted after waiting more than two minutes.
- This intersection had the highest average number of non-compliant vehicles of the five-lane crossings studied.

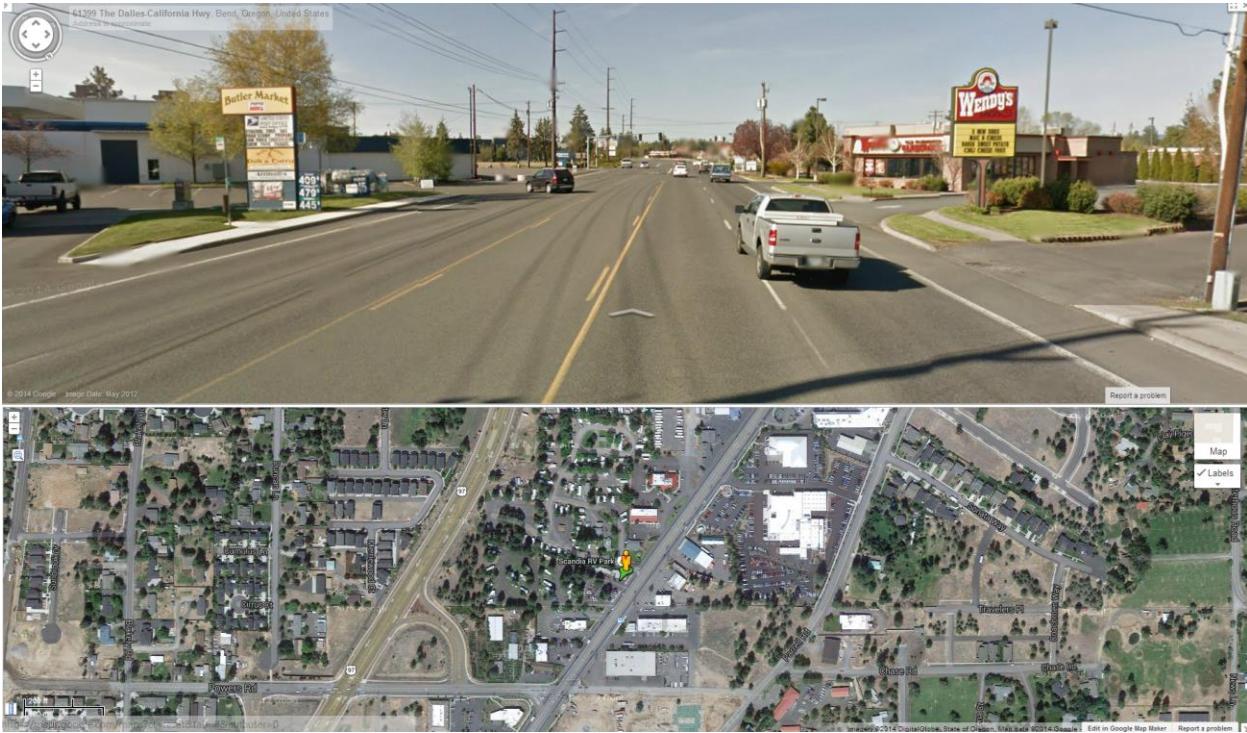
## 3RD STREET/300' NORTH OF POWERS

## Corridor Crossing Plan: Powers Road

Intersection Name: 3rd Street, North of Powers Road

The crossing of SE 3<sup>rd</sup> Street north of Powers Road was observed on Wednesday, August 13<sup>th</sup>, 2014 from 4 to 5 p.m. This crossing location was selected to accommodate crossings between the transit stop at the gas station on the east side of SE 3<sup>rd</sup> Street and the commercial uses (including Wendy's) on the west side of SE 3<sup>rd</sup> Street. At the crossing location north of Powers Road, SE 3<sup>rd</sup> Street has a five-lane cross-section, including four travel lanes and a center turn lane.

Five lane crossings were staged and observed between the northern entrance to the gas station on the east side of SE 3<sup>rd</sup> Street and the entrance to the Scandia RV Park on the west side of SE 3<sup>rd</sup> Street. Crossing gaps reflect vehicle platooning resulting from upstream and downstream signals.

Southbound vehicles were slowing for the Powers Road signal as they passed the crossing area. Pedestrians generally were required to cross in two-stages, using the two-way center turn lane as a refuge. Therefore, the summary statistics reflect the number of vehicles passing on the two lanes closest to the pedestrian. Drivers were eight times more likely to yield to a pedestrian waiting in the median than a pedestrian on the sidewalk.
