WINDOW ASSESSMENT KEY

Window Assessment - Exterior

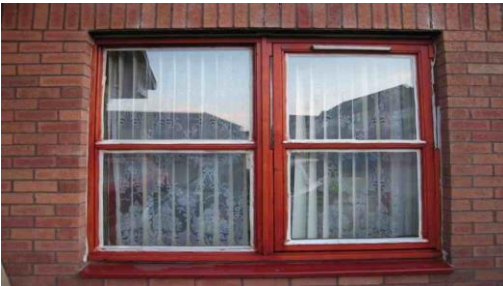
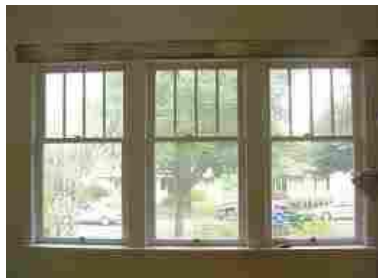
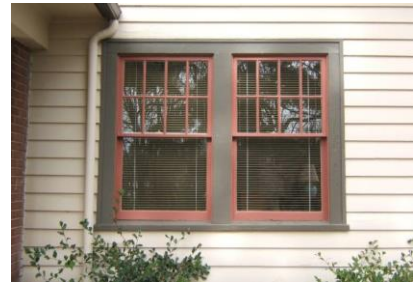
Good: General health is pretty good overall but minor repairs might be needed in 1 -2 years. Includes:

- No rot detected.
- Little or no paint is failing.
- Some seams and joints maybe open.
- Cleaning off mildew and/or debris may be necessary.

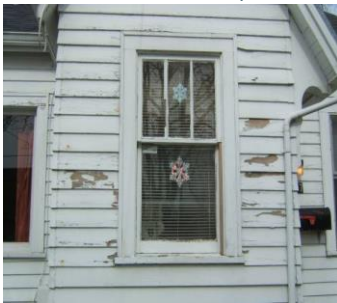
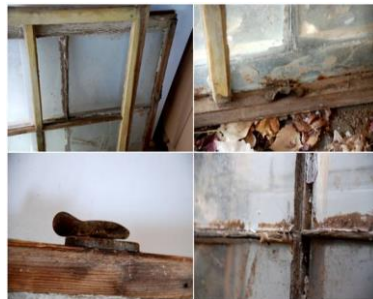
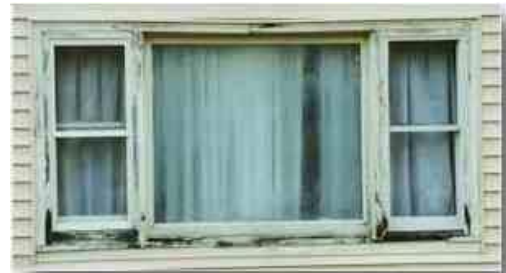
Fair: Some areas of repair needed. Includes:

- Larger openings at seams and joints, over 1/16"
- Small areas of rot, under 1"
- Paint failing in certain sections
- Some water infiltration, condensation and/or glazing missing
- Rotten sills and casings
- Minor operational issues i.e. hardware problem or sash ropes cut

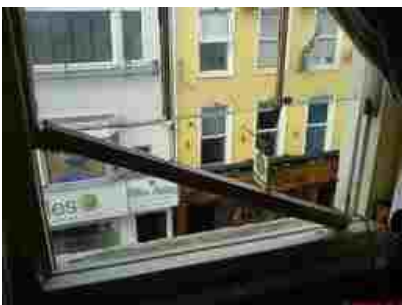
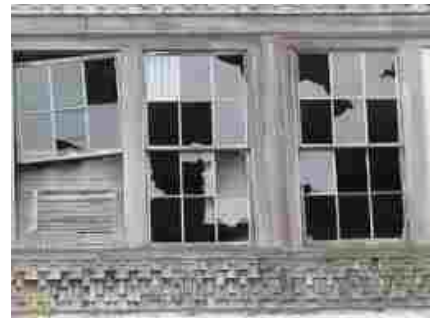
Poor: Window with sections needing replacement and/or serious rehabilitation needs to be done soon. Includes:

- Completely rotten sills or casings, 50%-70% gone.
- Glazing putty gone and muntins are broken, rotten or missing.
- Broken panes that allow water to infiltrate.
- Completely rotten or missing sashes.
