Chapter 18: Lead-Based Paint and Historic Preservation

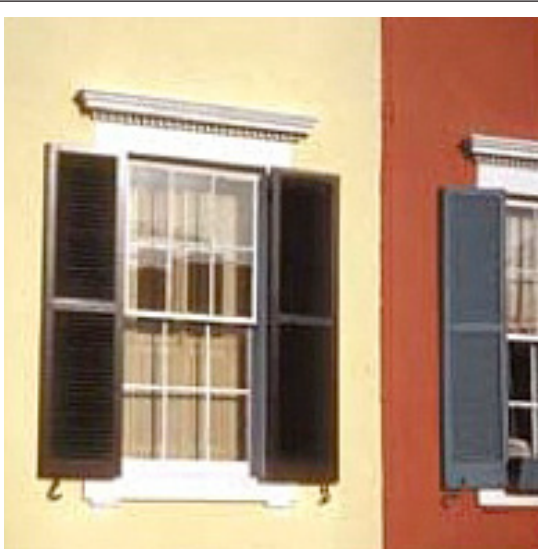
FIGURE 18.1 Delicate muntins and multi-pane sash on early 19th century row houses. Photo Courtesy National Park Service.

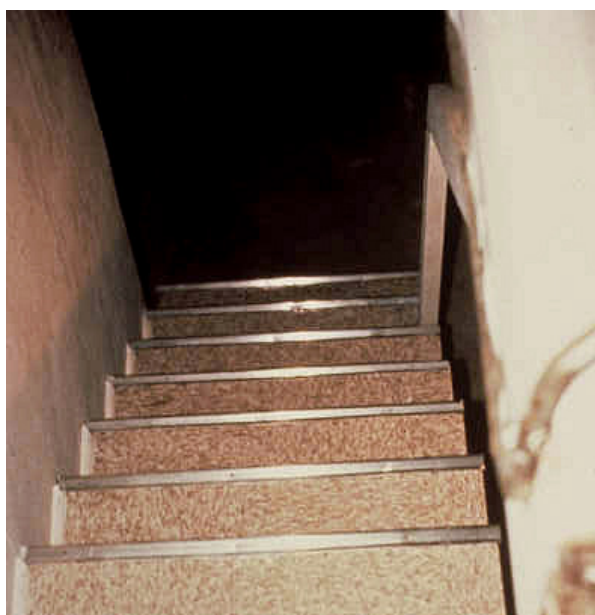
FIGURE 18.6 Enclosure of stairs in this manner is generally not appropriate in a historic property.

Enclosing a decorative feature may be appropriate if doing so does not damage the structure beyond a minimal amount (see Figure 18.6). For example, a projecting mantel might be enclosed if the fireplace is not to be used in the interim, and the decorative finishes are to be enclosed behind drywall finishes. While this is a serious loss of historic character, if it is a temporary solution and no harm is done to the feature, it might be an appropriate treatment. The use of artificial siding over painted and otherwise sound historic exteriors often results in a removal of projecting historic elements, such as roof brackets, and conceals the historic trim. The use of these artificial sidings is not recommended.
