Tumalo Creek 2022 Fish Monitoring Report

City of Bend - Bridge Creek Water System

Nate Dachtler, Bend/Fort Rock Ranger District Fisheries Biologist

November 29, 2023

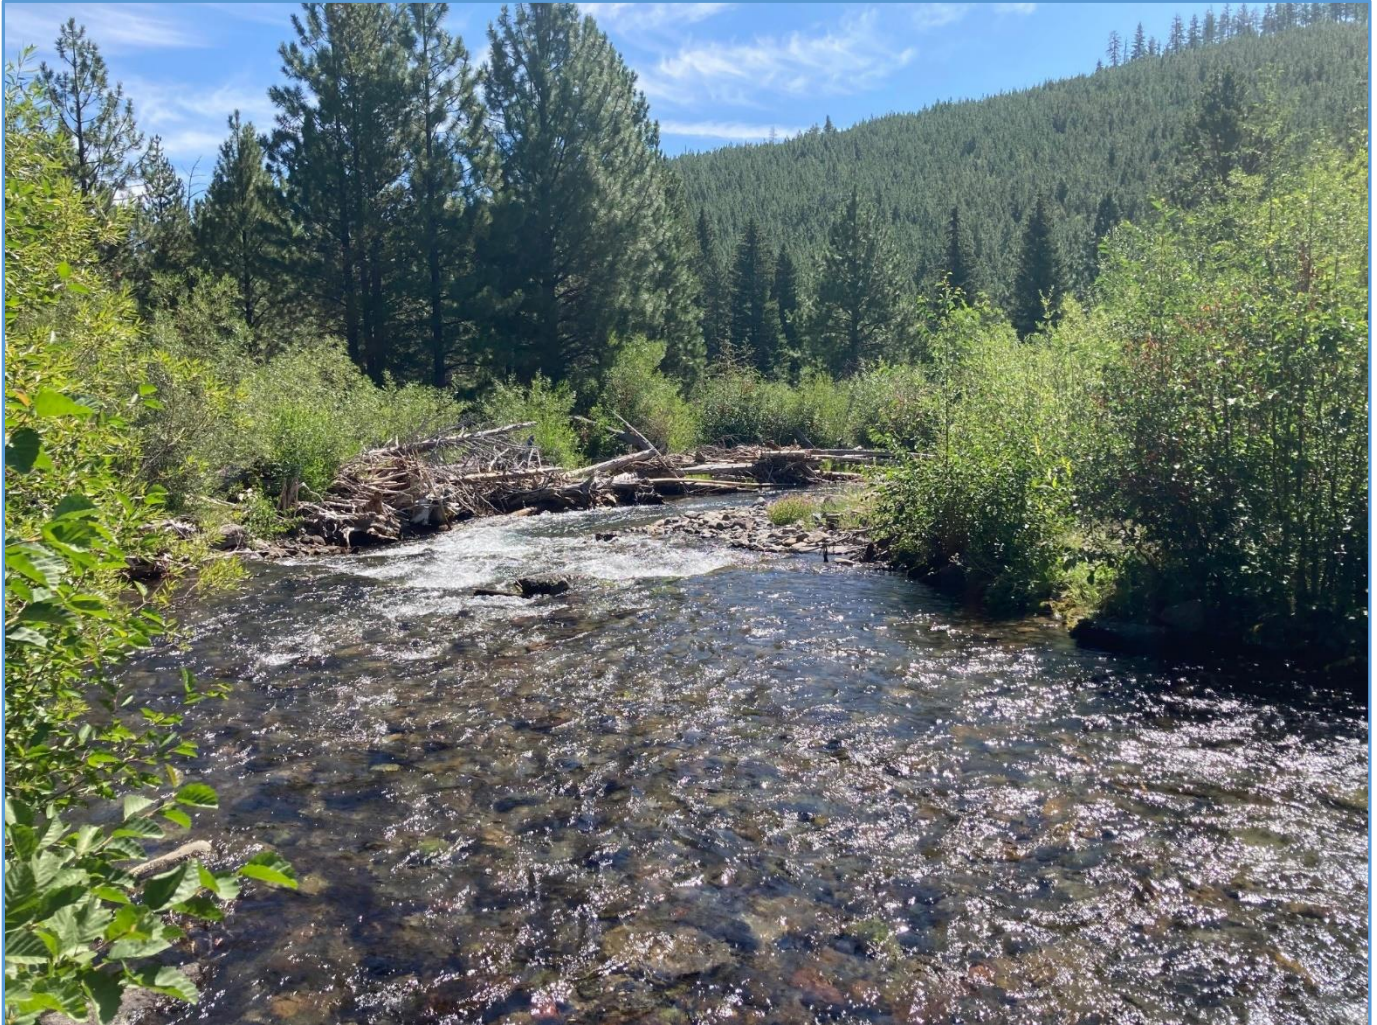
Tumalo Creek snorkel survey fish monitoring site #22 (A1-RR Upper)

Site 22 (A1-RR Upper): This site is within the Tumalo Creek Bridge to Bridge Restoration Project area and is characterized by relatively moderate gradient (1.67%), high density of LWM, and cobble and gravel substrate along with the boulder vane structures. The site is a mixture of riffle and pool habitats, with depths up to 5 feet. The site also includes a low gradient side channel (22SC) that is a mixture of very shallow and narrow riffle and pools 2-4 feet deep, with silty bottoms. The riffles are too shallow to snorkel, and the site has very heavy brush cover. The boulder vanes and side

channel pools were part of a forest service restoration project implemented in 2004-2005. Side channel data was collected separately from main channel data since the habitat is very different.

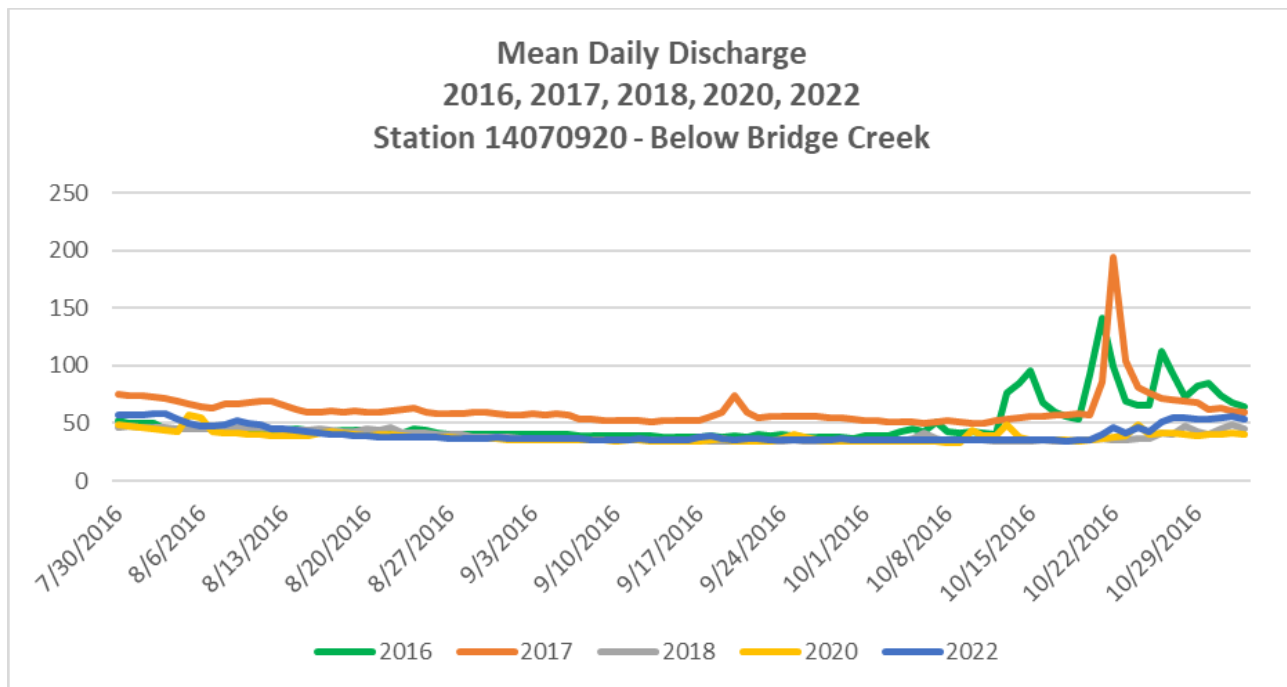
Figure 13. Station 14070920 Mean Daily Discharge Comparison from July 30 to November 2 of 2016, 2017, 2018, 2020 and 2022.

Figure 13 displays the discharge at the newly established gaging station immediately below the junction of Bridge Creek and Tumalo Creek during the fall when snorkel surveys were conducted. Discharge can influence fish behavior and movement, and the ability to observe them. Discharges between survey years were fairly similar with the exception of 2017 which had substantially more discharge during the entire year with a spike in the fall. In 2016 there were three higher flow spikes in the fall.
