# SEDIMENTATION MANHOLE

## Maintenance Guideline

UTILITY DEPARTMENT

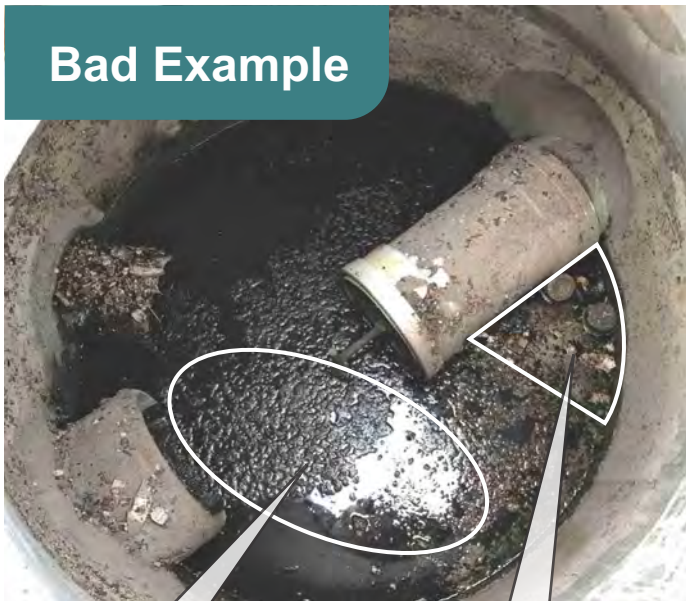
## Bad Example

Oily sheen on water surface. Maintenance needed per manufacturer's recommendation.

Trash and debris on water surface. Maintenance needed per manufacturer's recommendation.

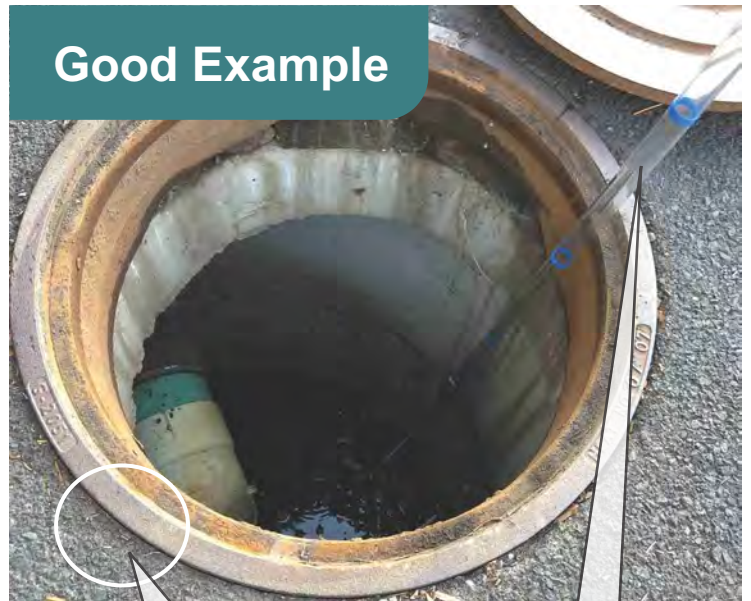
## Good Example

Rim not damaged, pavement in good condition.

A rigid sediment measuring device needed for inspection.
